**Sediment Impact Investigation Report
Amber Brook/Hamilton Reservoir Confluence**

**Mashapaug Road
Holland, Massachusetts**

MMI#3684-01

July 2008

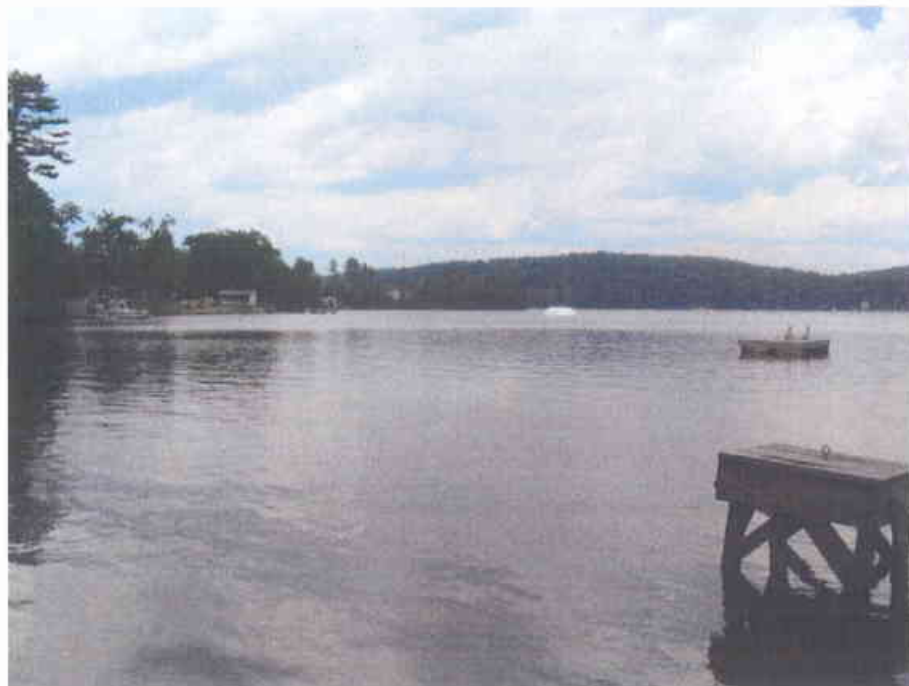
the site, and in the Amber Brook watershed. Appendix A contains a photo log of the site visit. As can be seen in photos 1A through 4A, while water clarity was good on the day of field investigations, Hamilton Reservoir in the area of Amber Brook has been notably impaired with previously deposited sediment. The NC/HF shoreline parcel appeared stable, with no indication of active erosion into Amber Brook or Hamilton Reservoir.

Photo 1A
Hamilton Reservoir near Mashapaug Road.

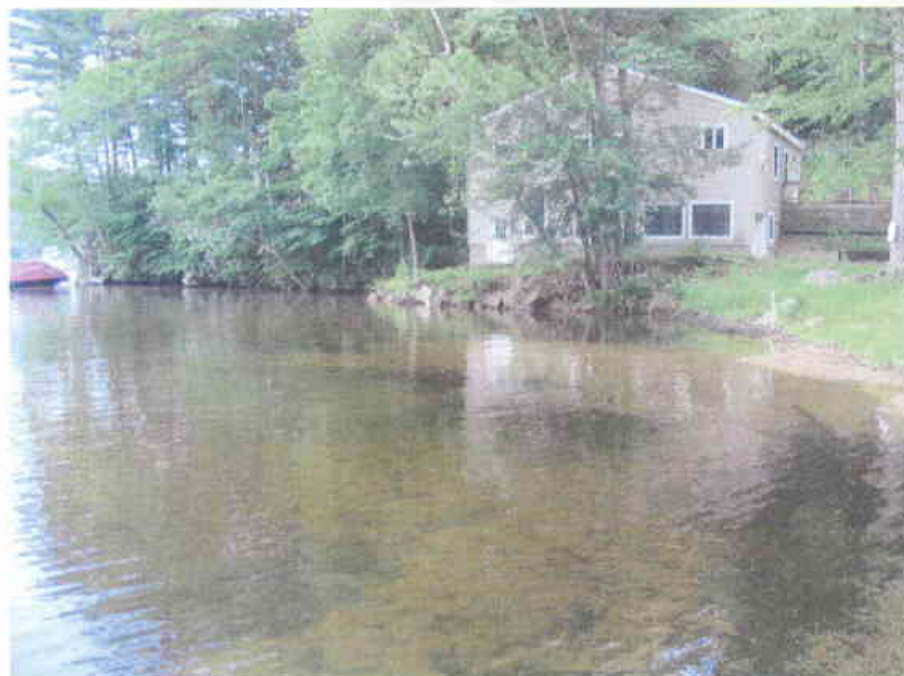
Photo 2A
Hamilton Reservoir near sediment delta downstream of Amber Brook outlet.

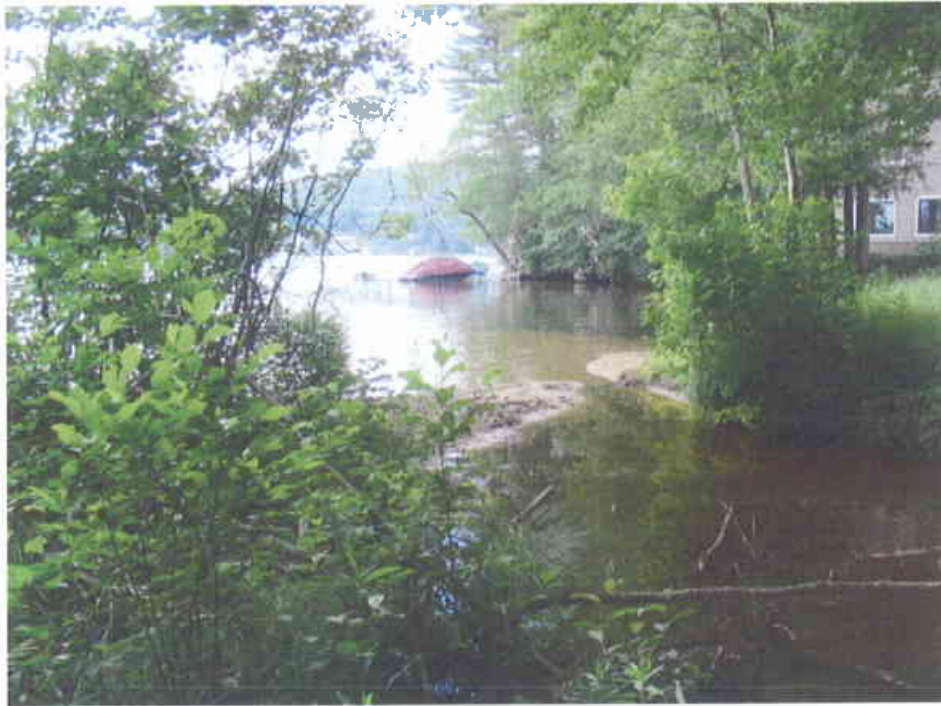
Photo 3A
Amber Brook at outlet to Hamilton Reservoir.

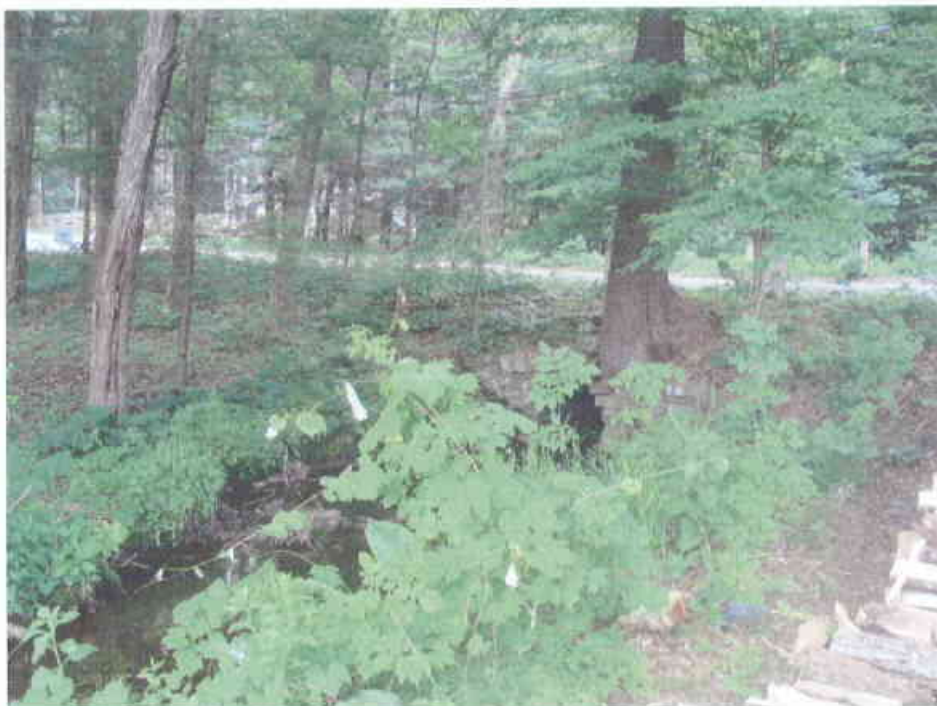
Photo 4A
Amber Brook flowing beneath Mashapaug Road to Hamilton Reservoir.

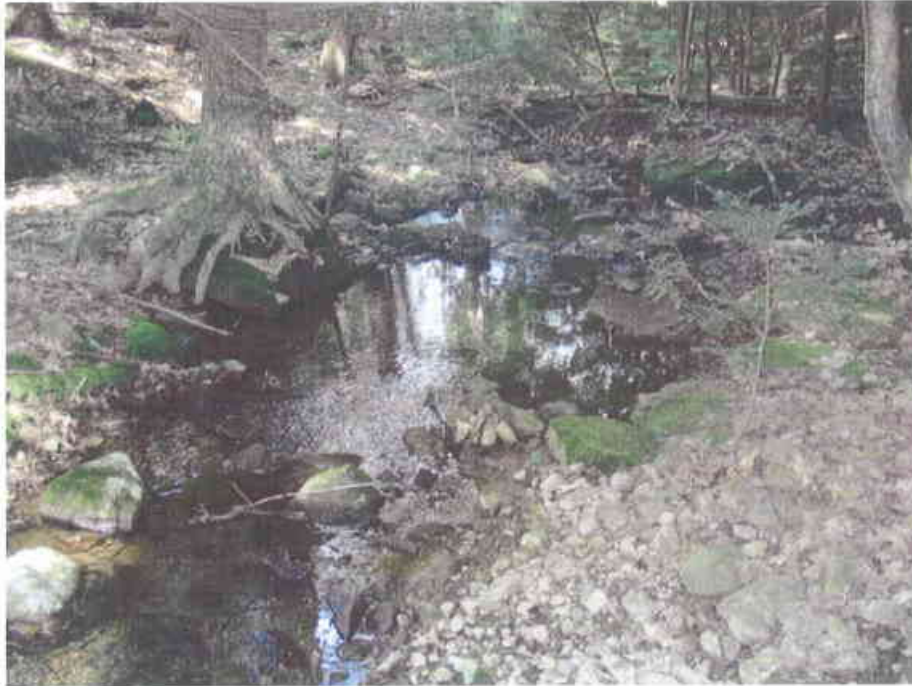
An access road to the NC/HF parcel off Mashapaug Road runs parallel with Amber Brook, with an approximate 100-foot width vegetative strip between the access road and the brook. On the northern (upslope) side of the access road, several interim sediment basins have been constructed to provide pre-treatment via detention of runoff from the north and east. The access road is unpaved, with silt fence and haybales along the southern edge of the road, as can be seen in Figures 5A and 6A. On the day of inspection, the vegetative strip between the access road and Amber Brook was free of sediment deposition, as was the brook through this reach. This area is depicted on Figures 7A and 8A.

Photo 7A
Amber Brook adjacent to NC/HF property.

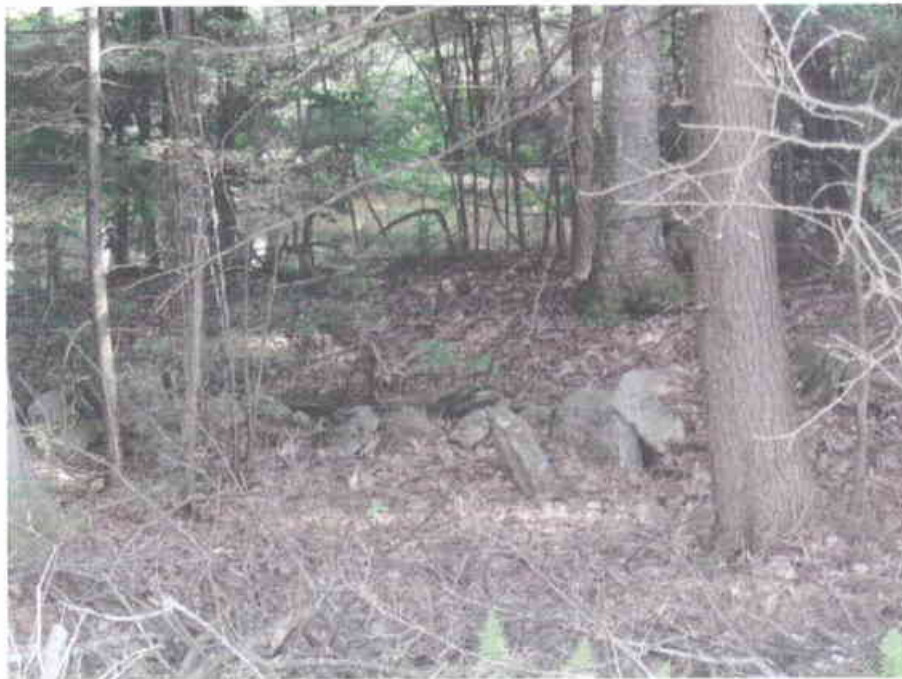
Photo 8A
Vegetative buffer strip between NC/HF access road and Amber Brook.

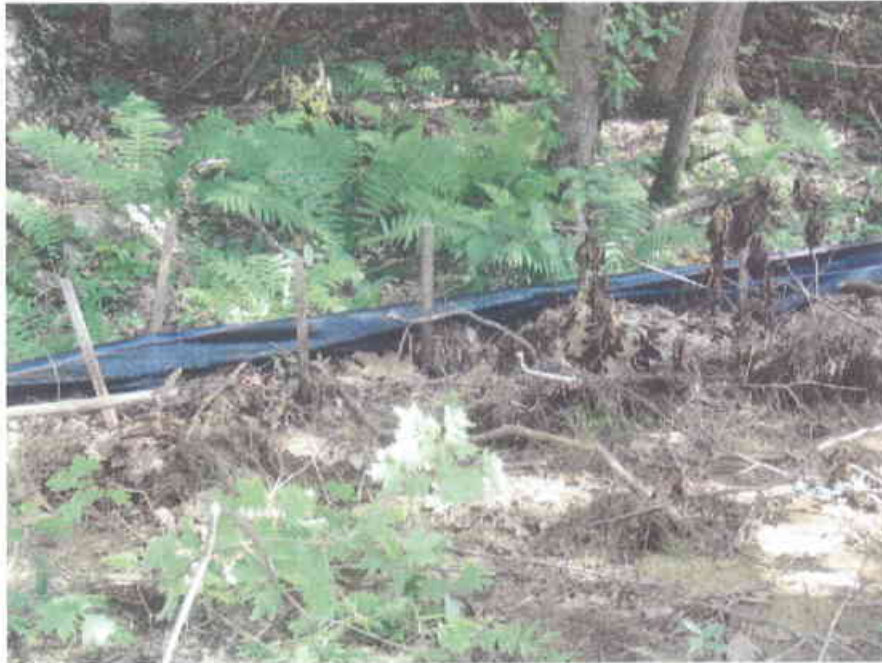
Photo 9A

Silt fencing along portions of the access road (shown in Figures 9A and 10A) had clearly contained a significant amount of sediment and while there was no evidence of failure, some areas were in need of maintenance where sediment accumulations were approaching the top of the fence. There was no evidence that sediment had migrated through the vegetative buffer or into Amber Brook.

Silt fence adjacent to (south of) NC/HF access road near Amber Brook.

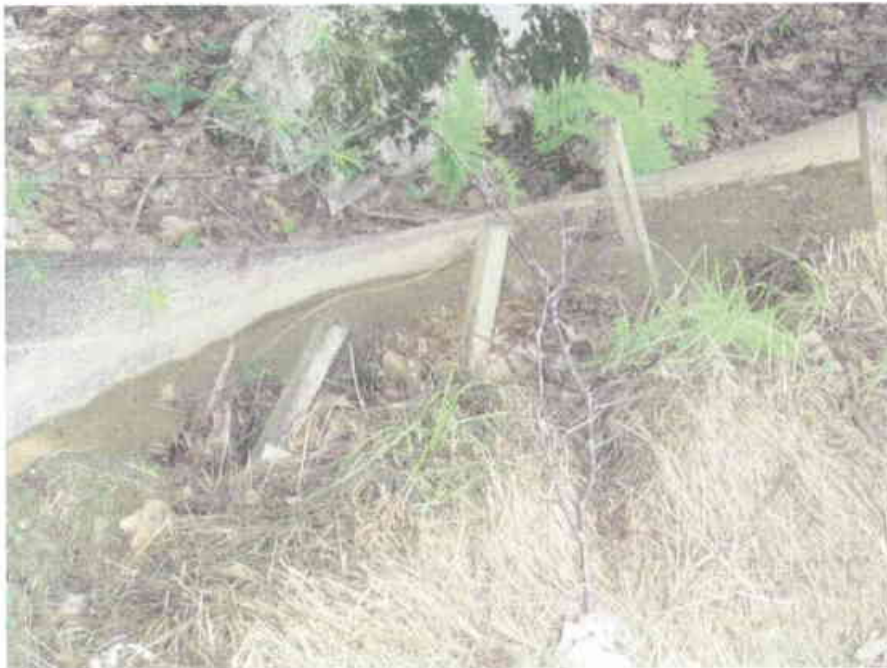
Photo 10A

Original haybales and silt fence placed adjacent to (south of) NC/HF access road.

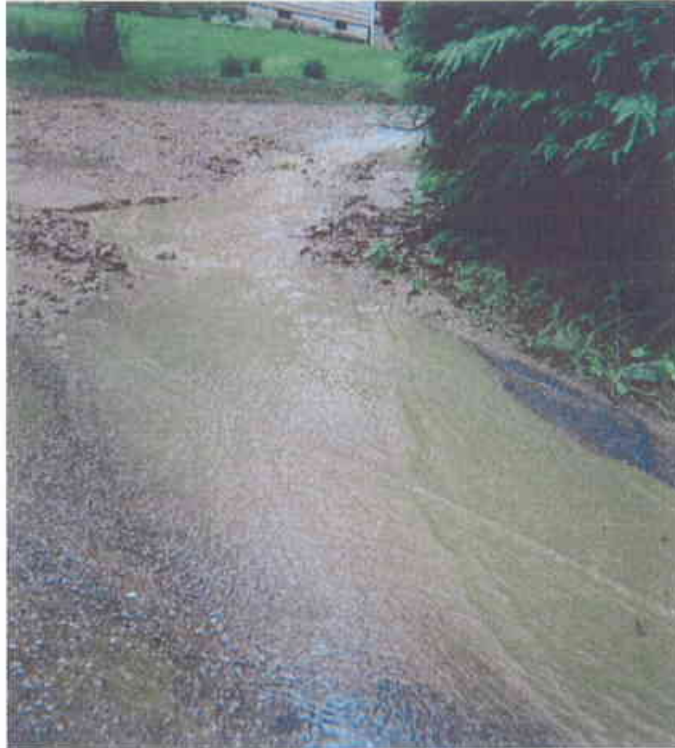
Photo 1B
Sediment laden runoff coming from Park Road.

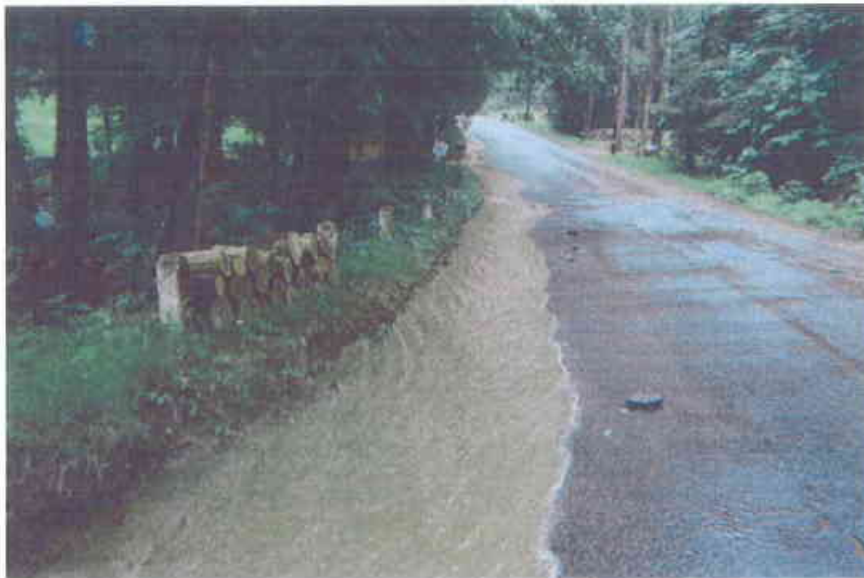
Photo 2B
Roadway runoff from Mashapaug Road and Union Road
flowing onto Northeast Concepts' shorefront property.

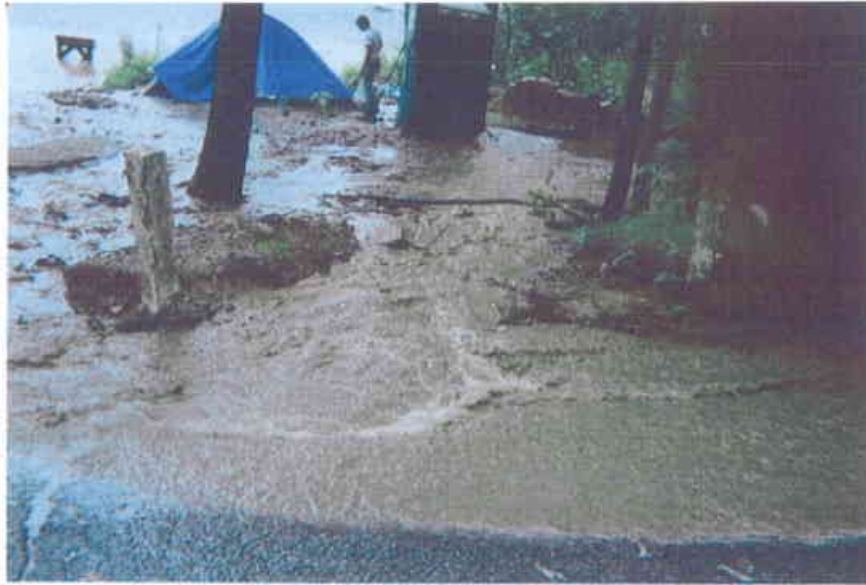
Photo 3B
Runoff from Mashapaug Road and Union Road
flowing onto Northeast Concepts' shorefront property.

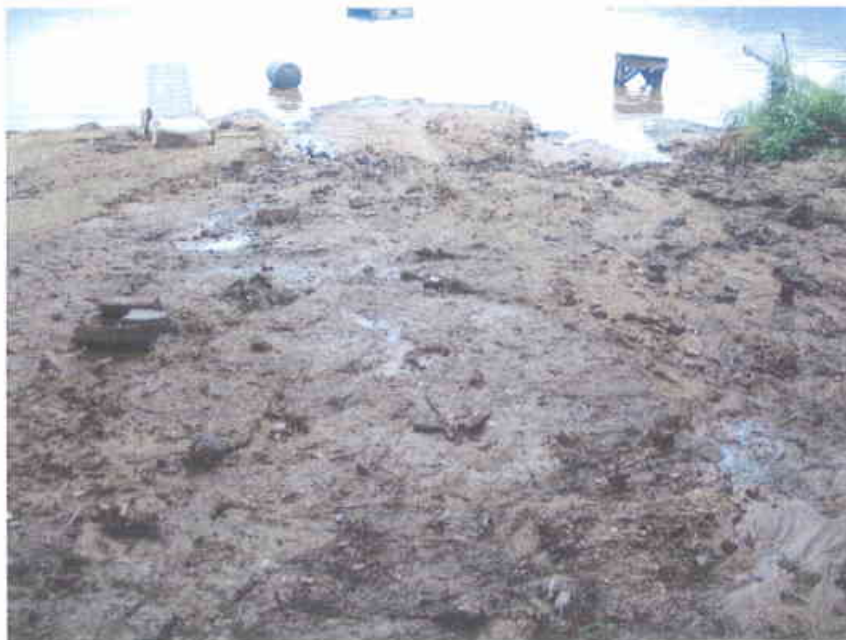
The NC/HF private shoreline property is located along the east side of Mashapaug Road. Several rills and large sandy sediment deposits were observed on the surface of native soil. Several small diameter tree sapling stumps were found intact beneath the recent sediment deposition. A photo log of the June 23, 2008 site visit is included herein as Appendix B. Based on photographs taken by NC/HF on June 23, 2008, it is evident that the sediment on the private beach was coming from Town owned gravel/sandy roads and private driveways (see photos 1B through 4B). Town-owned roads include Amber Road, Park Road, and Union Road. These travelways are not paved and have relatively steep grades (see photos 5B through 10B). There was no evidence that the recently deposited sediments found on the shorefront property were coming from the NC/HF access road or elsewhere on the site located across Mashapaug Road.

Photo 4B
Sediment deposits from June 23, 2008 rain storm atop native soil and at Northeast
Concept shoreline property off Mashapaug Road.

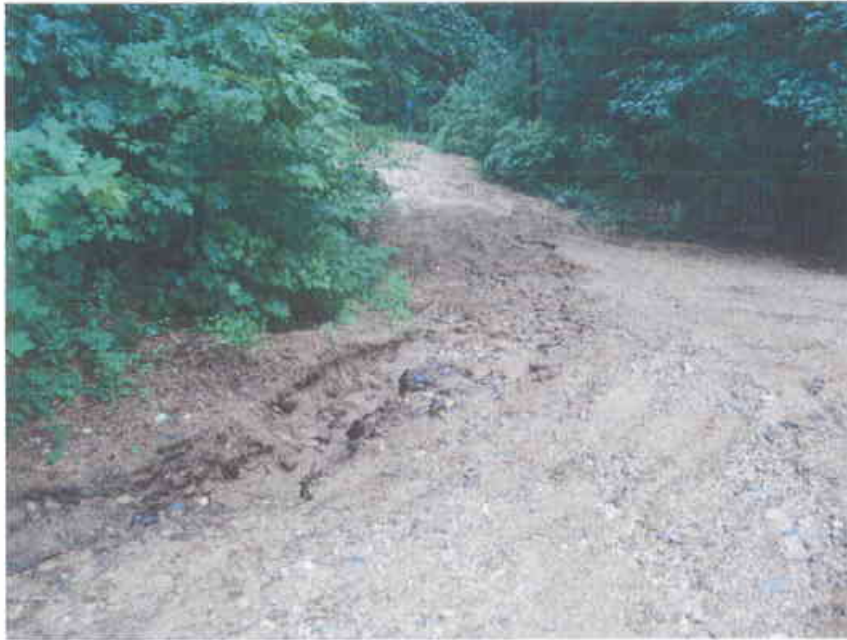
Photo 5B

Rills formed on Short Road as a result of June 23, 2008 storm event.
Suspended solids being transported directly into Amber Brook.

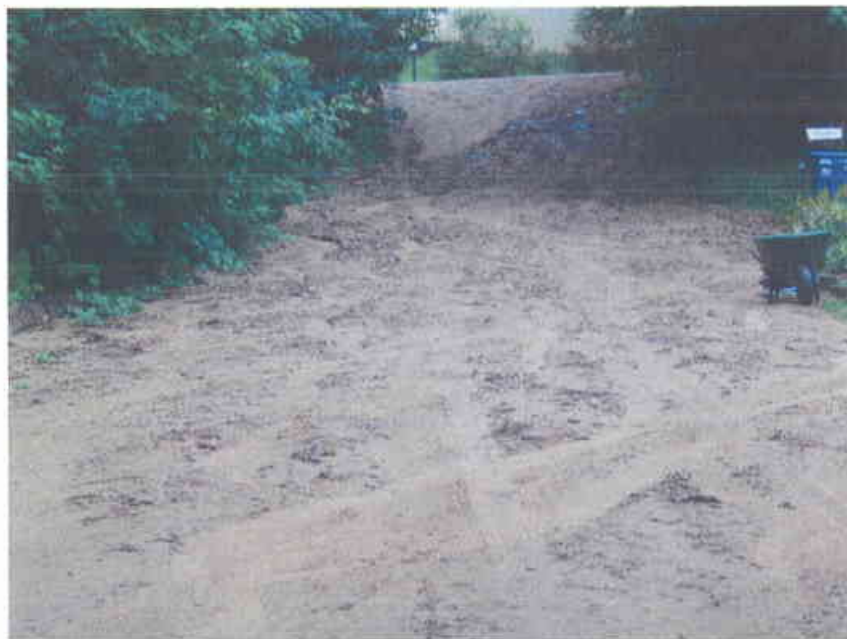
Photo 6B

The watershed is predominantly forested and has a mix of single family homes, most of which are serviced by sand and gravel roads and driveways. Many of the roads and driveways have steep slopes (see photos 6B and 8B). The combination of steep slopes and highly erodible soils on these roads makes them susceptible to significant erosion, as was documented by MMI on June 23, 2008. Photos 1B, 2B, and 9B through 12B document the erosion that occurred in the watershed. Rills and suspended sediments were observed flowing into the historic sediment basin at the corner of Mashapaug Road and the NC/HF access drive.

Rills observed on Short Road and Brook Road following rain
event on June 23, 2008.

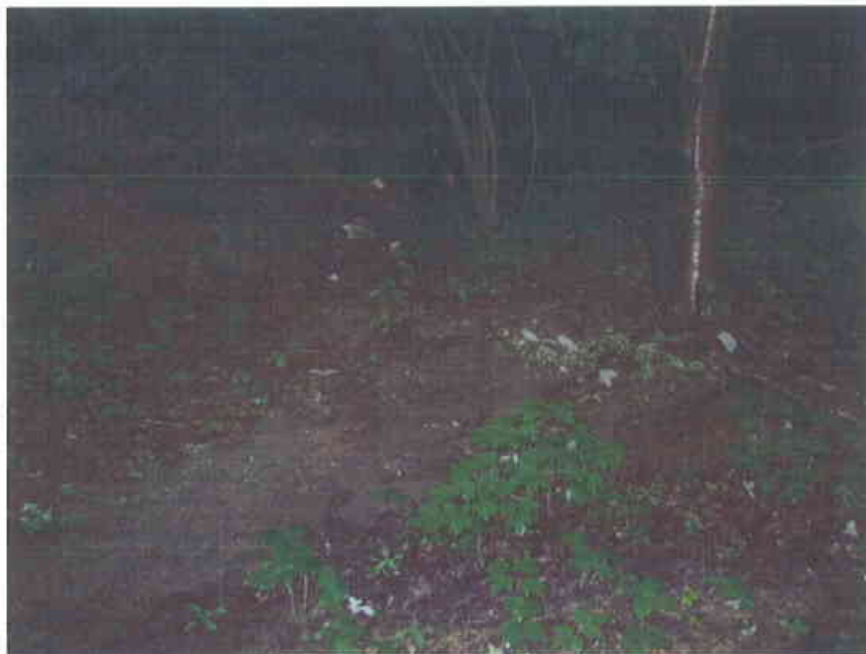
Photo 7B

On the right (east) bank of Amber Brook and opposite of the NC/HF property, MMI observed several rills that had recent alluvium and sediment deposits within them and all were discharging directly into Amber Brook (see photo 7). The source of these rills and sediment deposits were traced back to the Town owned roads known as Short Road and Brook Road (see photos 5B and 6B). The surface water within the neighboring private pond had turbid water. This pond is acting as a sediment basin for Amber Brook. In fact, the pond has likely been made shallower by the continual deposition of sediment from Town owned road stormwater runoff.

Sediment deposits found within Amber Brook riparian forest zone downgradient from Short Road. Sediment discharges directly into Amber Brook.

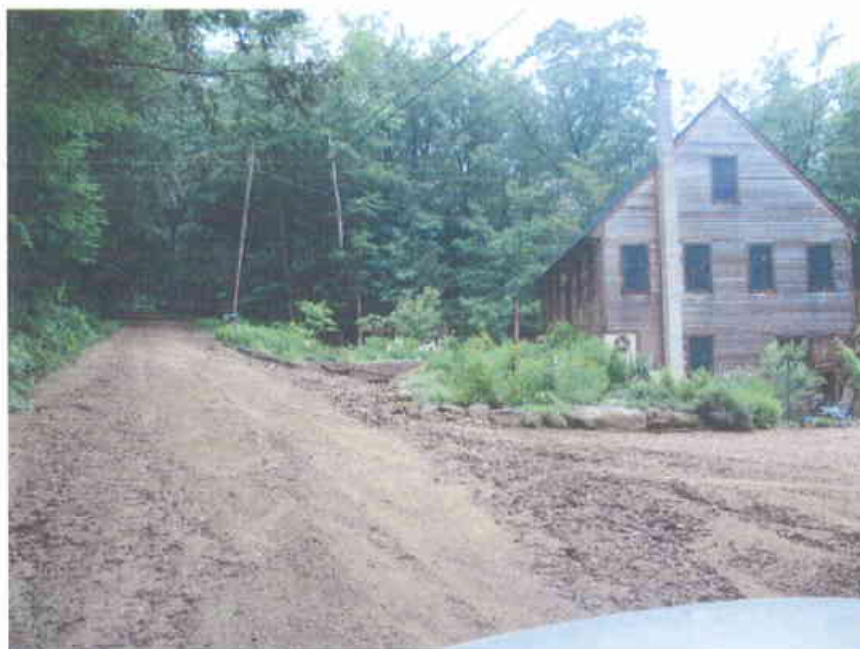
Photo 8B

Large rills on Amber Road.

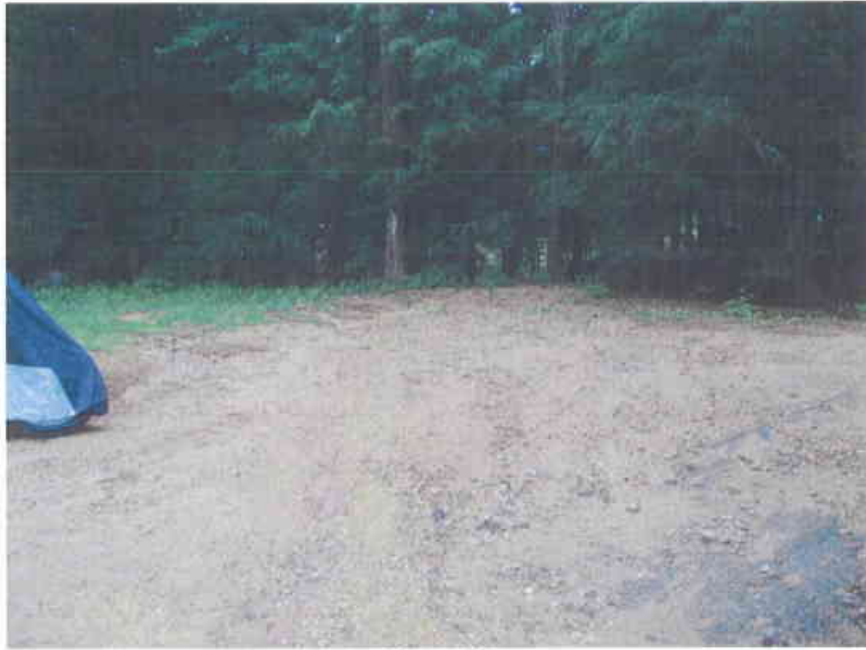
Photo 9B

Sediment deposits on Amber Road that are flowing towards Amber Brook.

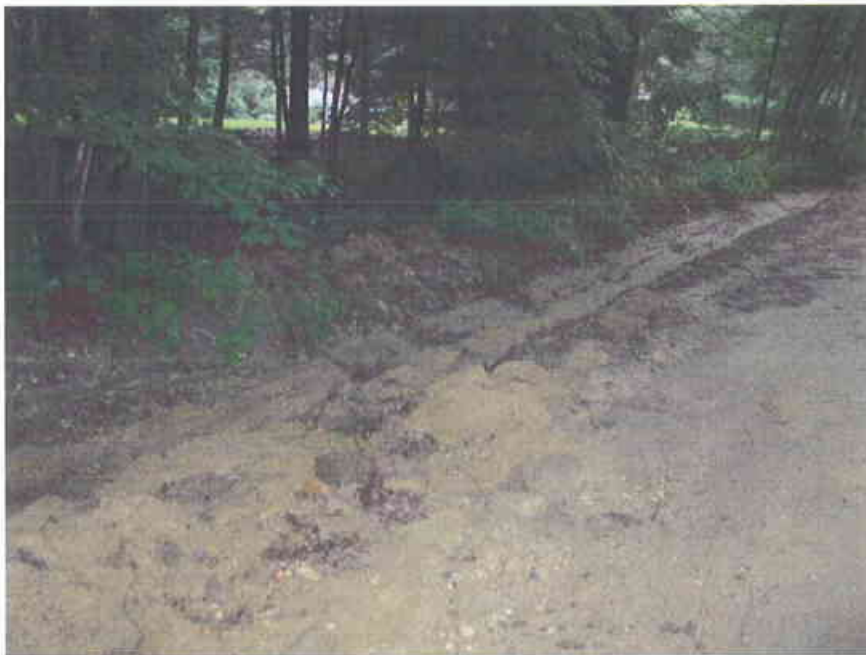
Photo 10B

Manmade swale along north edge of Amber Road that drains to a Town catch basin located at the corner of Amber Road and Union Road. Large quantities of sediment within the swale dumps directly into catch basin, which is piped directly into Amber Brook.

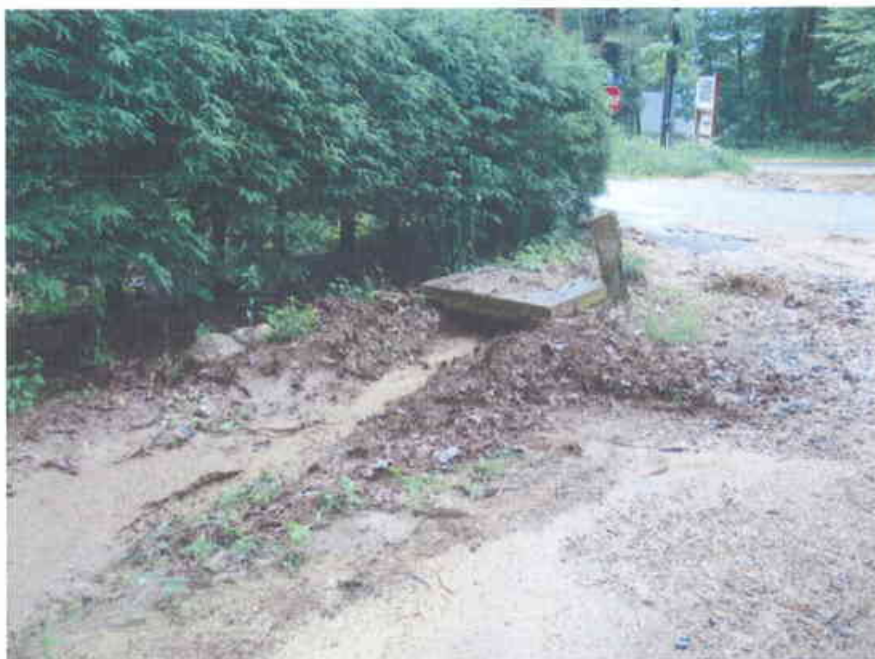
Photo 11B

Catch basin located at corner of Amber Road and Union Road that is collecting sediment from Amber Road and discharging sediment directly into Amber Brook.

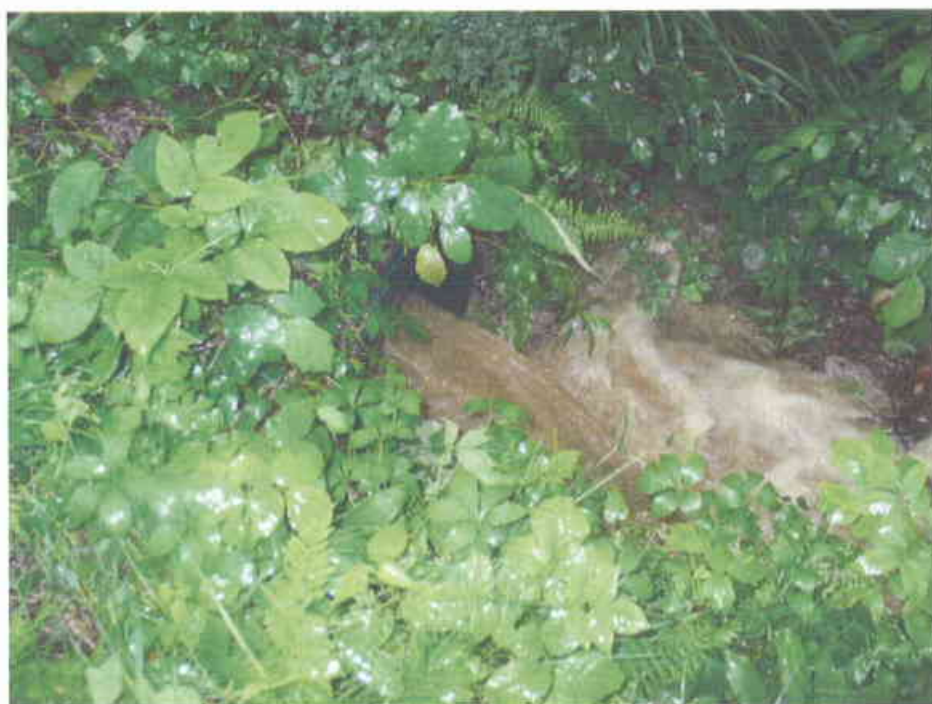
Photo 12B

Based on the review of the historic aerial photographs it is evident that the sediment delta was present well before NC/HF began their forestry operations and that the most likely cause of the sediment delta is the uncontrolled erosion within the watershed and along Town owned roads located within the Amber Brook watershed. The delta continues to grow because the roads and driveways consistently erode each year. All drainage ditches and catch basins from Amber Road and Union Road, which are full of sediment, are directed into a 15-inch SLCPP (smooth lined corrugated plastic pipe) (see photo 12B) and are discharged directly into Amber Brook on the west side of Mashapaug Road.

Town owned SLCPP (smooth lined corrugated plastic pipe) outfall discharging sediment laden runoff directly into Amber Brook. Runoff within pipe is being collected from Amber Road.

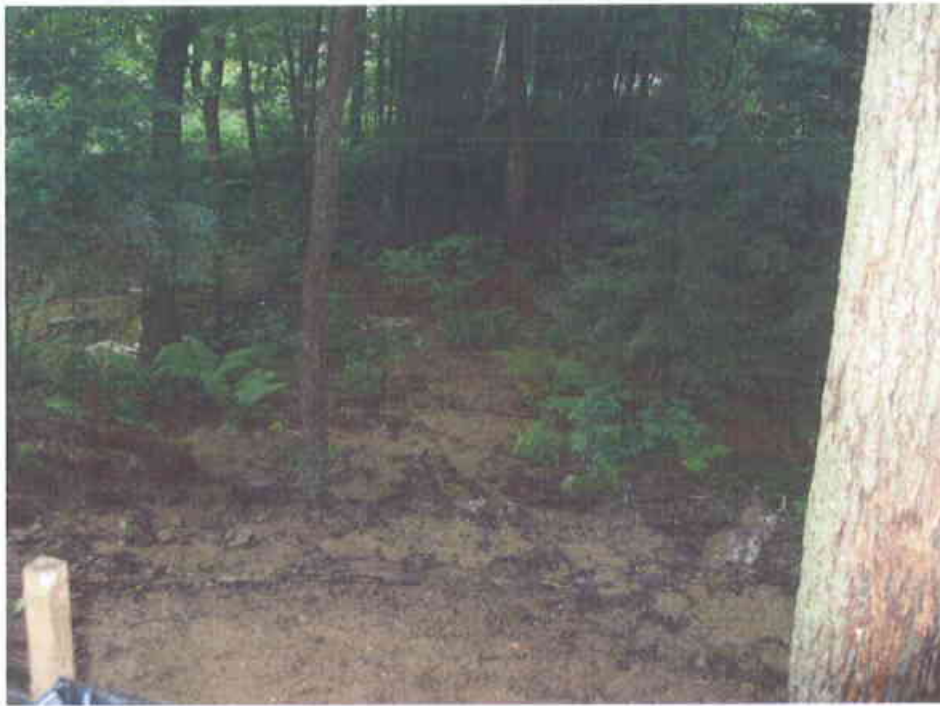
Silt fence has been installed along the southern edge of the access road and runs west along the "no cut/clear zone" as approved on the Forest Cutting Plan (see photo 15B). Down gradient of the filter fence, the historic sediment basin is located at the southeast corner of this property (see photo 13B). This basin was likely installed by a previous owner of the site, which at one time was known and operated as the Blodgett Farm. Remnants of other physical features, such as walls, swales, and berms are also evident throughout the site, indicative of previous activity on the land. The sediment basin receives stormwater runoff from Mashapaug Road as well as the NC/HF site. Stormwater that enters this sediment basin flows into Amber Brook via an overflow berm and then discharges through a pipe under Mashapaug Road.

Photo 13B
Historic sediment basin located at the corner of
Mashapaug Road and NC/HF access drive.

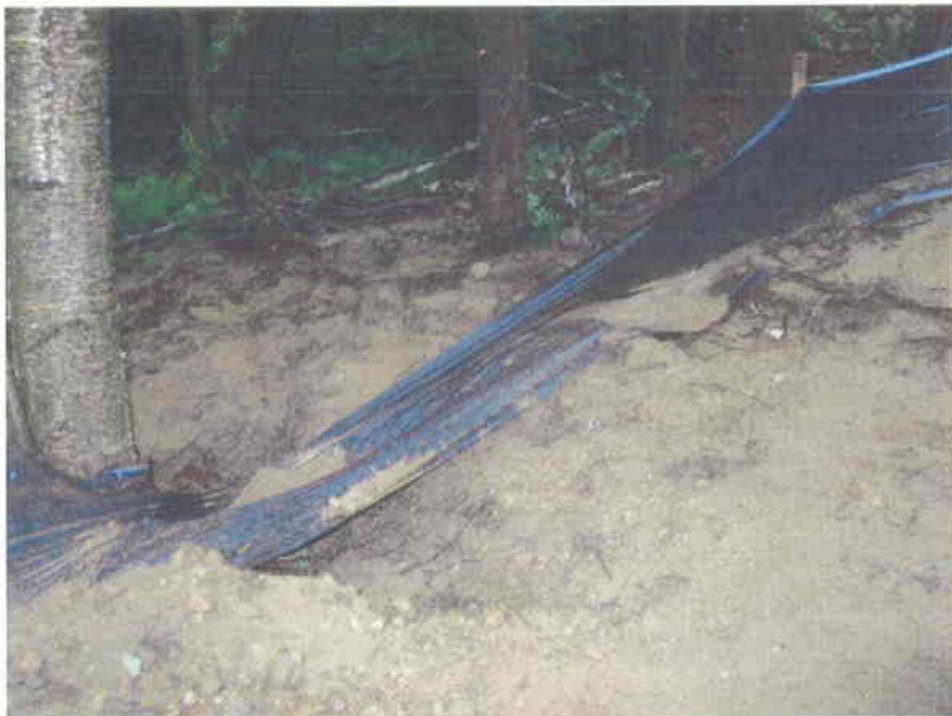
As can be seen in photos 14B and 15B, the silt fence along the access road was undermined at several locations. Exposed soils were found on the downgradient side of the silt fence and small rills were evident. These rills were also being directed to the sediment basin as previously described. There was no evidence that existing exposed soils were eroding directly into Amber Brook.

Photo 14 B
Silt fence undermining on NC/HF access drive.

- New hay bales were placed on the upslope side of the silt fence.
- Two small breeches in the silt fence were reinforced.
- The area on the eastern side of the silt fence was stabilized. Large woody debris was removed by hand; a metal rake was used to stabilize the area; and the area was seeded and covered with straw mulch.
- Three-inch crushed rock was installed in the drainage swale to help slow the water and stabilize the swale.
- Two berms were constructed on the access road to slow down runoff.
- The straw barrier at the outlet side of the sediment basin (upstream of the Mashapaug Road culvert) was reinforced to help filter runoff before discharging into Amber Brook.
- A small berm was placed along the shoreline site to help prevent sediment laden runoff along Mashapaug Road from depositing on the site.

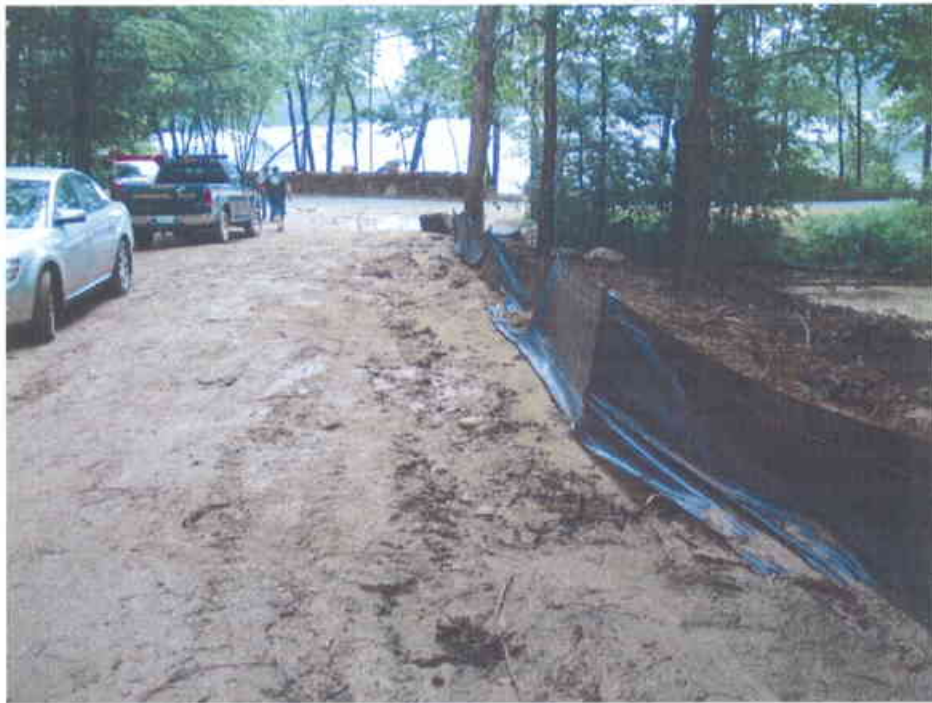
Photo 15B

Silt fence along NC/HF access drive protecting Amber Brook.

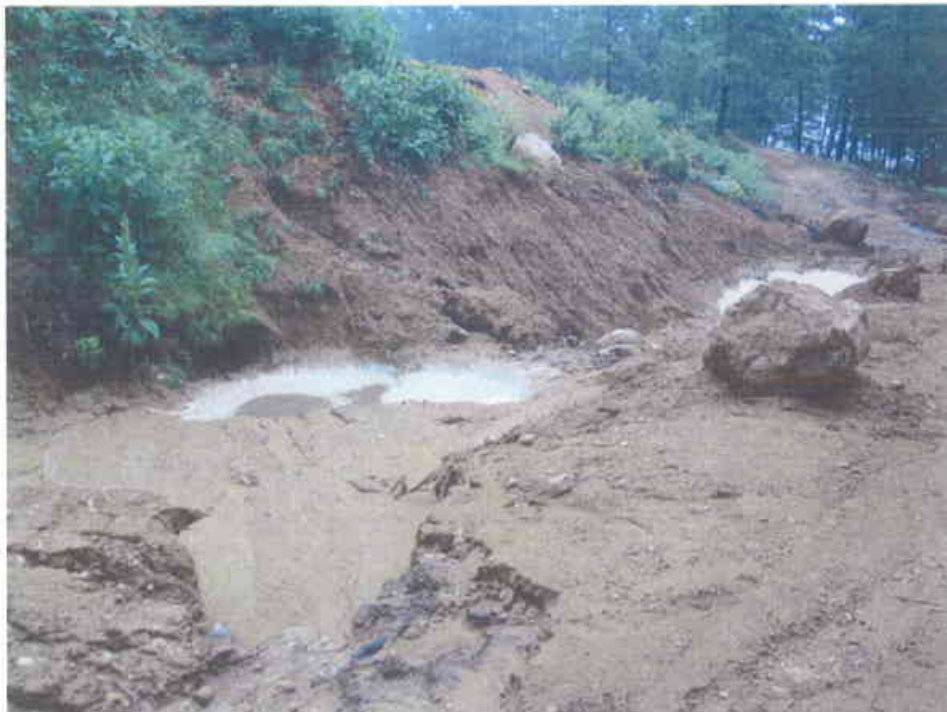
Photo 16B

The NC/HF private forestry and farming parcel is located along the west side of Mashapaug Road. The main entrance to the site runs parallel to Amber Brook and is a sand and gravel roadway. Interim sediment basins were actively catching runoff upgradient of the access road (see photo 16B) and upgradient of the silt fence. These sediment basins are located approximately 160 linear feet west of Mashapaug Road. They were constructed to help capture coarse grained material coming from exposed soil areas on site. Stormwater from these sediment basins is discharged across the existing access drive and is directed into a swale that flows east along the silt fence. Stormwater from within the swale is directed into an existing (historic) sediment basin located on the east side of Mashapaug Road.

Interim sediment basin traps constructed on NC/HF property.

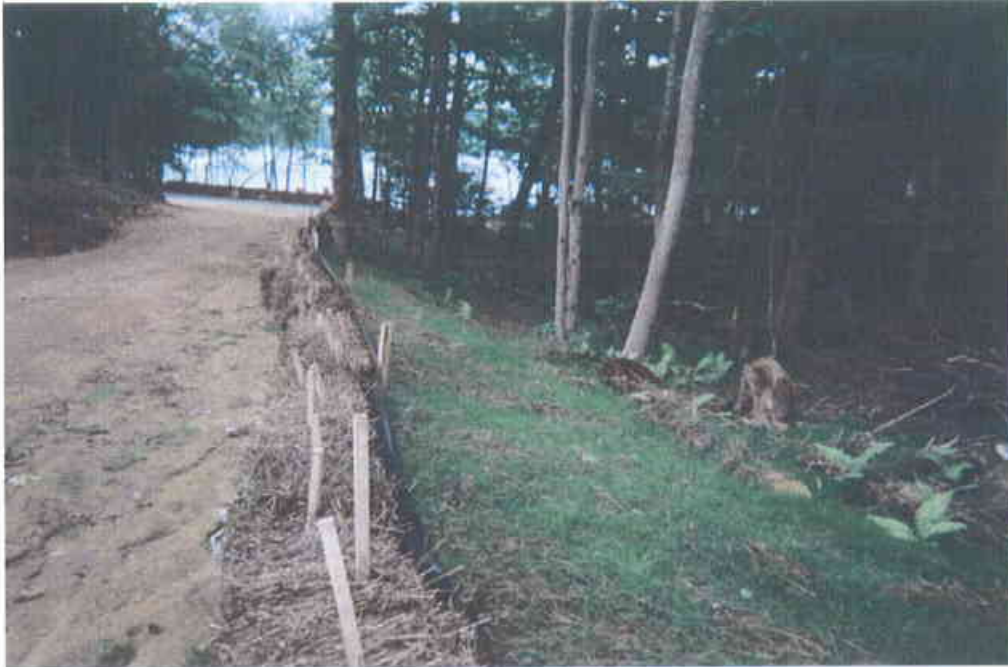
Photo 1C

Newly planted area and refurbished silt fence and haybales along entrance drive.

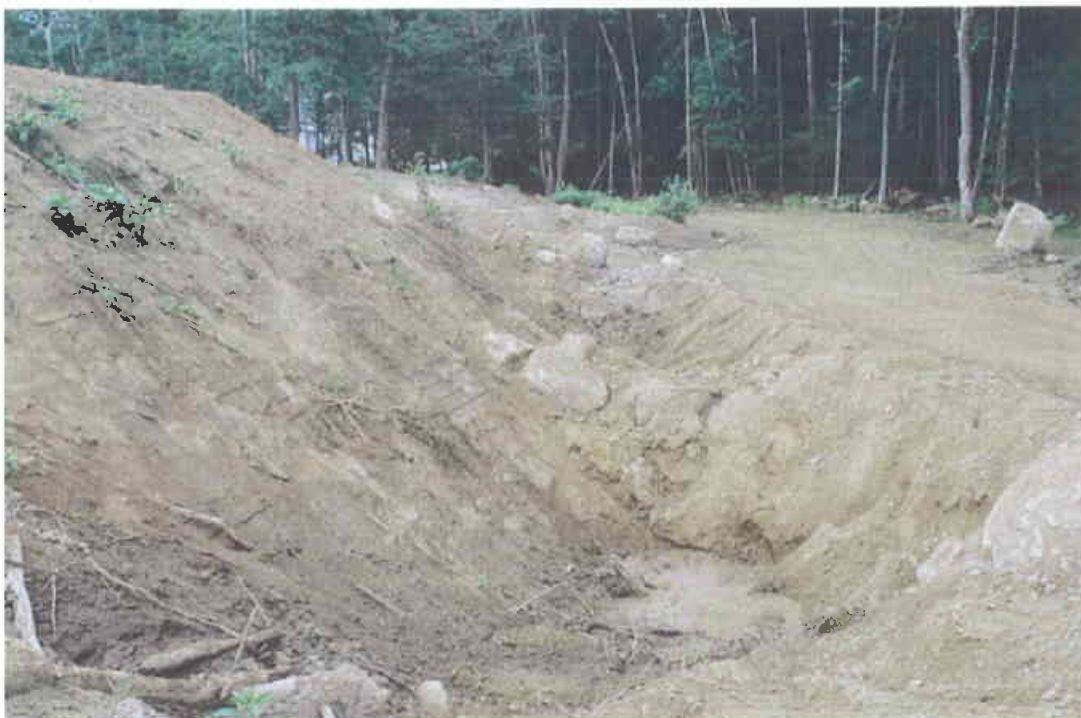
Photo 3C
Maintained interim sediment basin traps on NC/HF property.
View looking to the east.

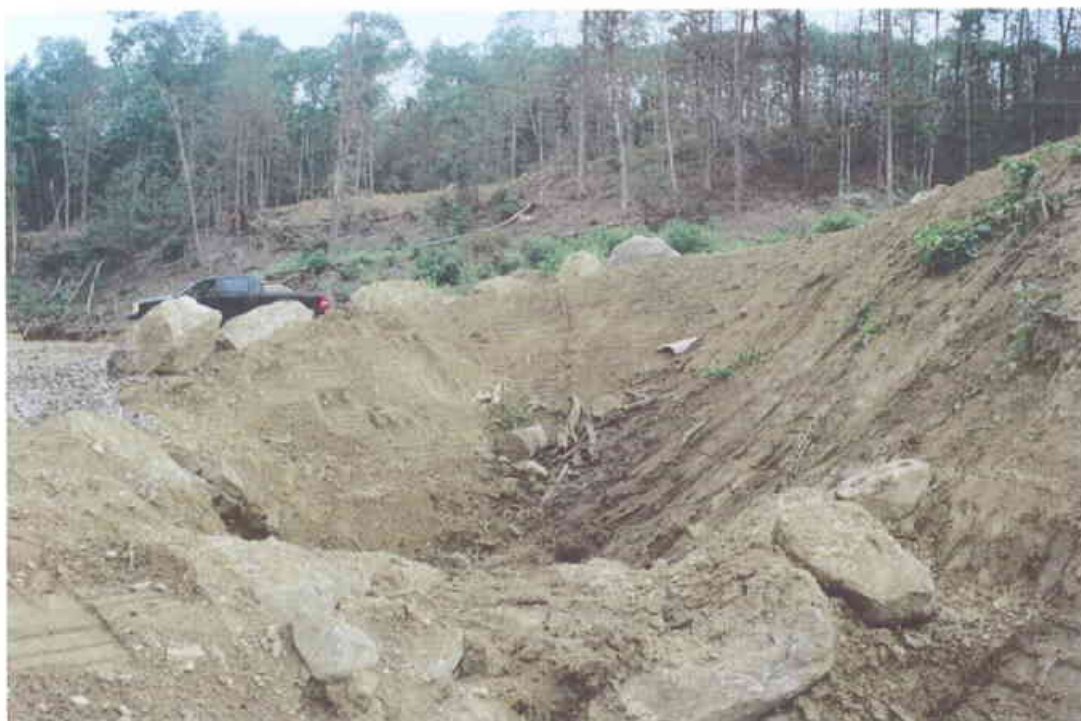
Photo 4C
Maintained interim sediment basin traps on NC/HF property.
View looking to the west.

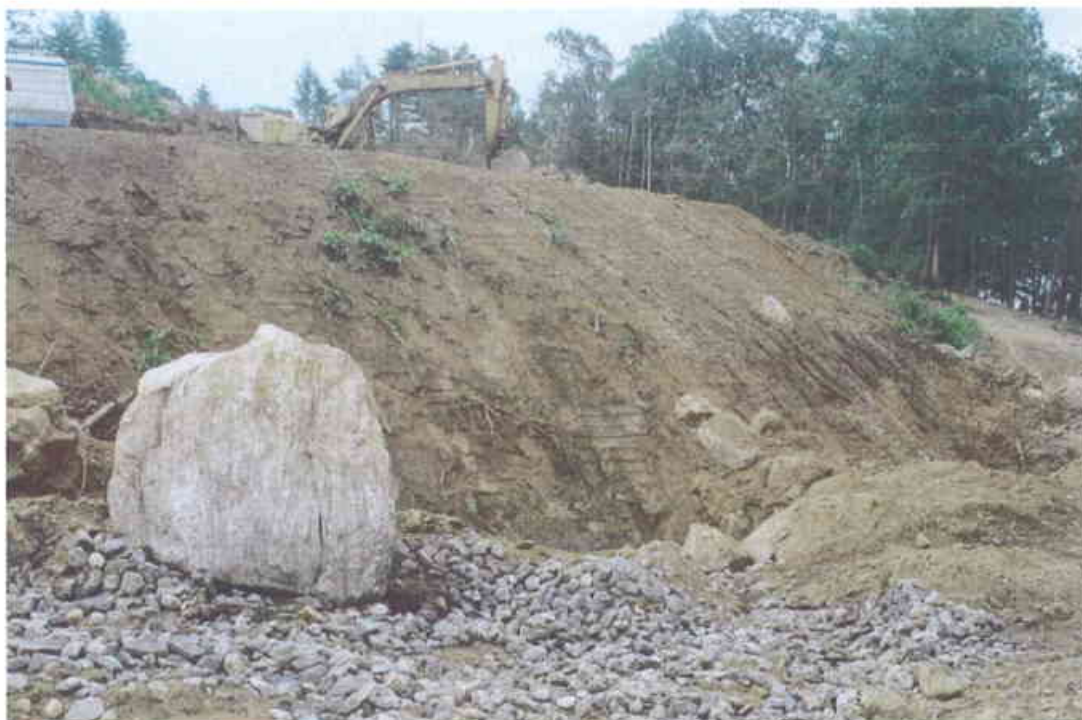
Photo 5C
Maintained interim sediment basin traps on NC/HF property.
View looking to the north.
