**Sediment Impact Investigation Report
Amber Brook/Hamilton Reservoir Confluence**

**Mashapaug Road
Holland, Massachusetts**

MMI#3684-01

July 2008

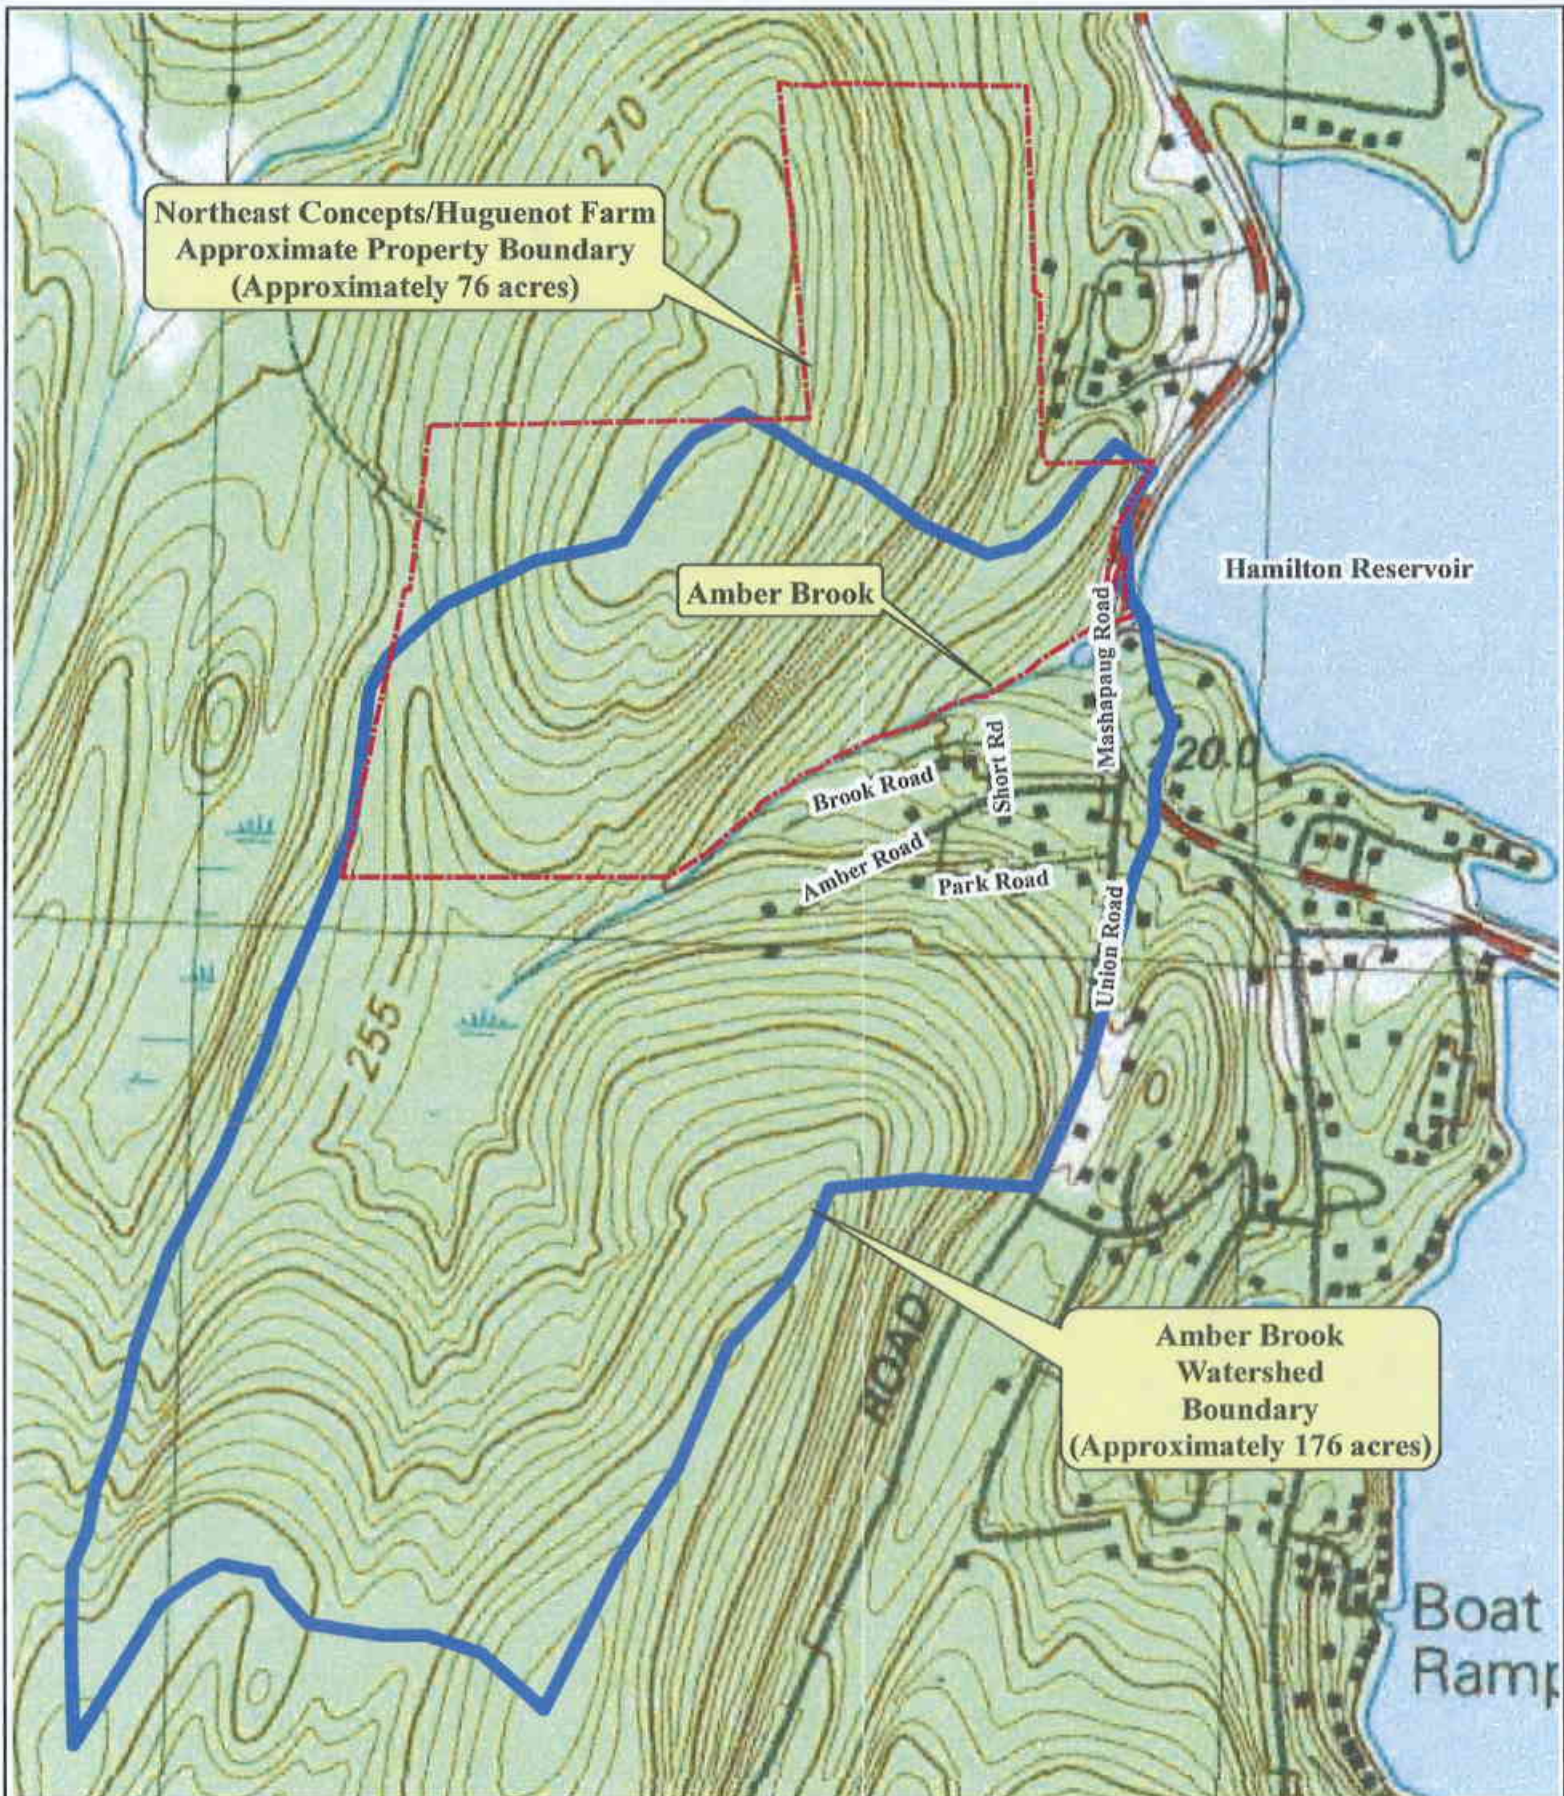
SHEET:
Figure 1

A reconnaissance of the Amber Brook watershed was also conducted on June 20, 2008. As can be seen in Figure 1, the watershed is very steep, with the exception of the headwater wetlands to Amber Brook. Many of the roads and driveways in the watershed are unpaved, with apparent ruts and rills from prior erosion. Catch basins did not appear to have sumps and no watershed detention basins were evident.

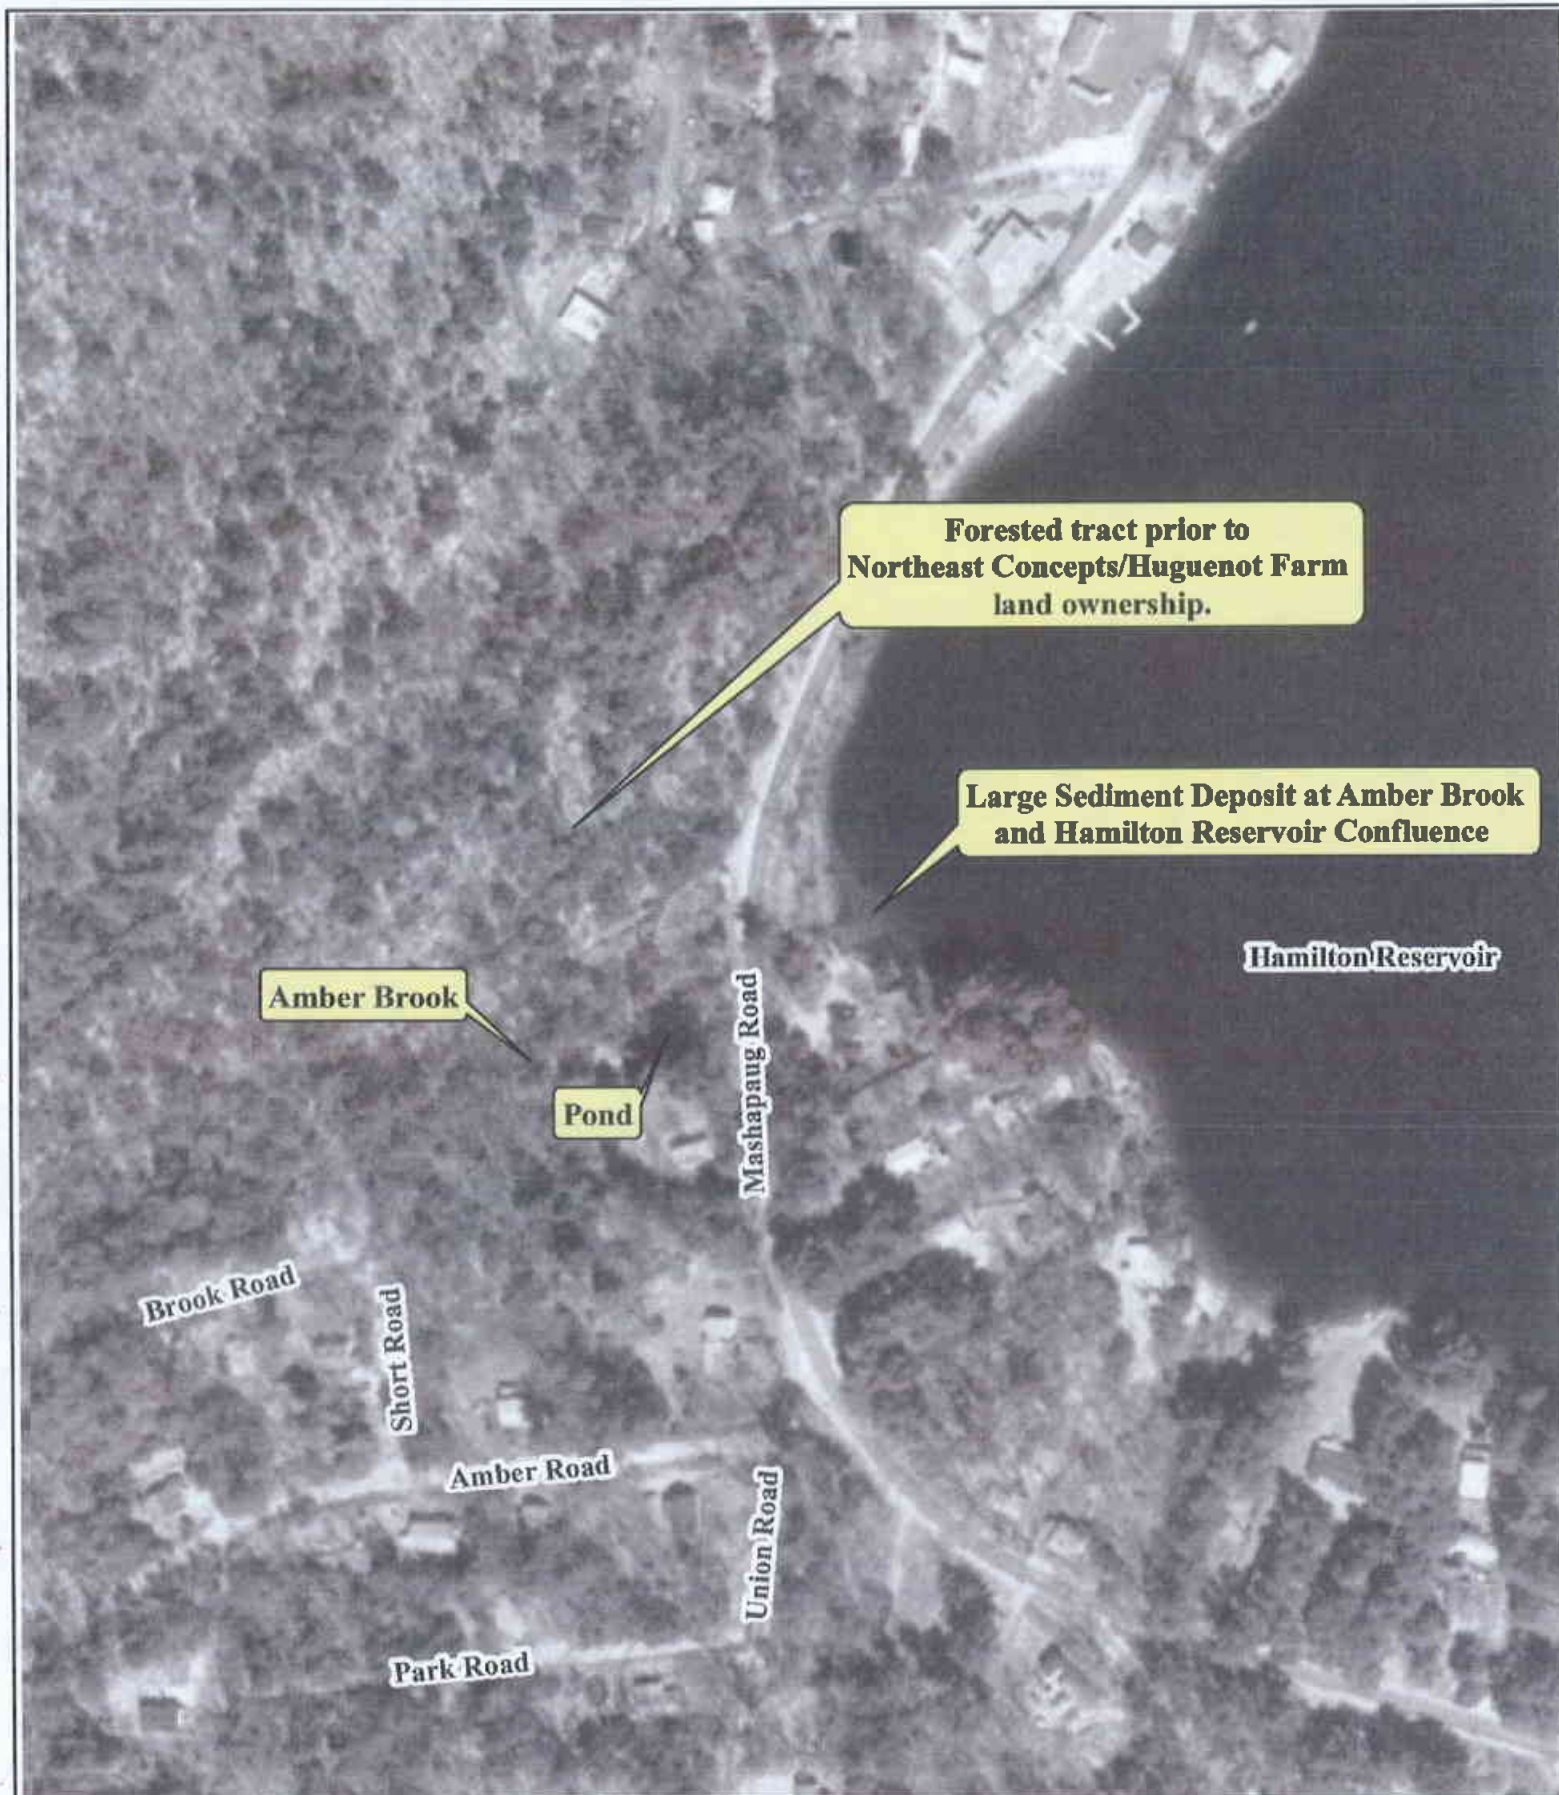
SHEET:
Figure 2

Based on the review of the historic aerial photographs it is evident that the sediment delta was present well before NC/HF began their forestry operations and that the most likely cause of the sediment delta is the uncontrolled erosion within the watershed and along Town owned roads located within the Amber Brook watershed. The delta continues to grow because the roads and driveways consistently erode each year. All drainage ditches and catch basins from Amber Road and Union Road, which are full of sediment, are directed into a 15-inch SLCPP (smooth lined corrugated plastic pipe) (see photo 12B) and are discharged directly into Amber Brook on the west side of Mashapaug Road.

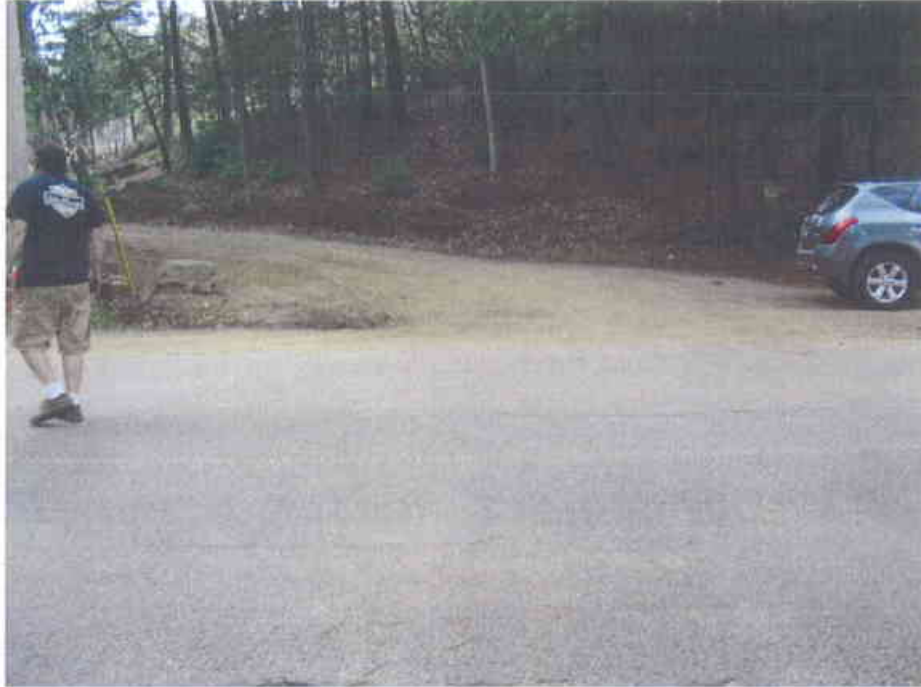
Photo 5A
View of entrance to NC/HF property across Mashapaug Road.

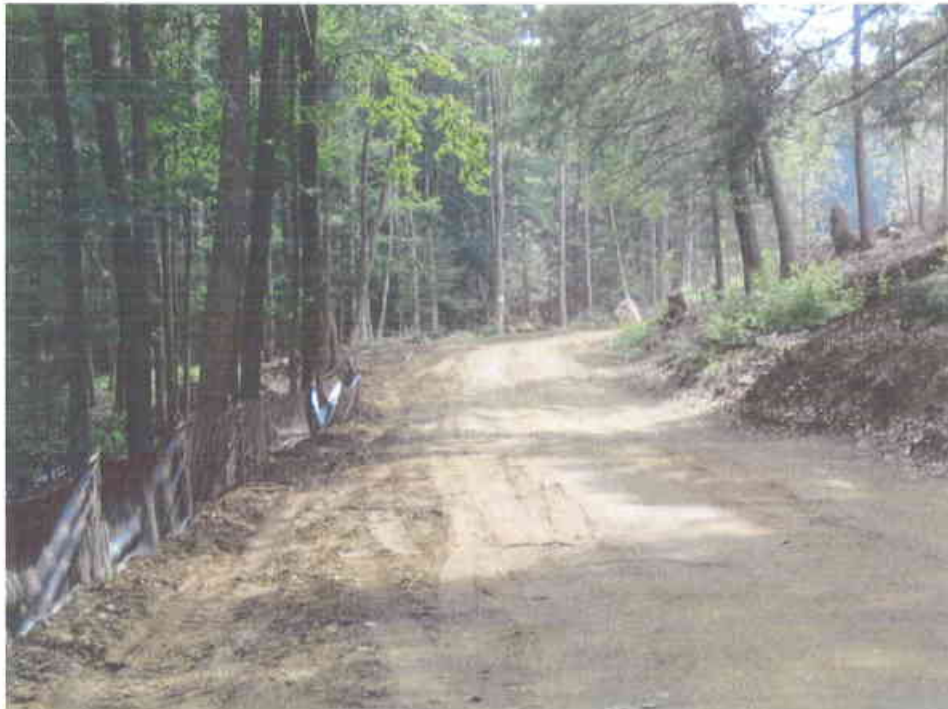
An access road to the NC/HF parcel off Mashapaug Road runs parallel with Amber Brook, with an approximate 100-foot width vegetative strip between the access road and the brook. On the northern (upslope) side of the access road, several interim sediment basins have been constructed to provide pre-treatment via detention of runoff from the north and east. The access road is unpaved, with silt fence and haybales along the southern edge of the road, as can be seen in Figures 5A and 6A. On the day of inspection, the vegetative strip between the access road and Amber Brook was free of sediment deposition, as was the brook through this reach. This area is depicted on Figures 7A and 8A.

Photo 6A
NC/HF Access Road. Amber Brook is to the left beyond the silt fence.

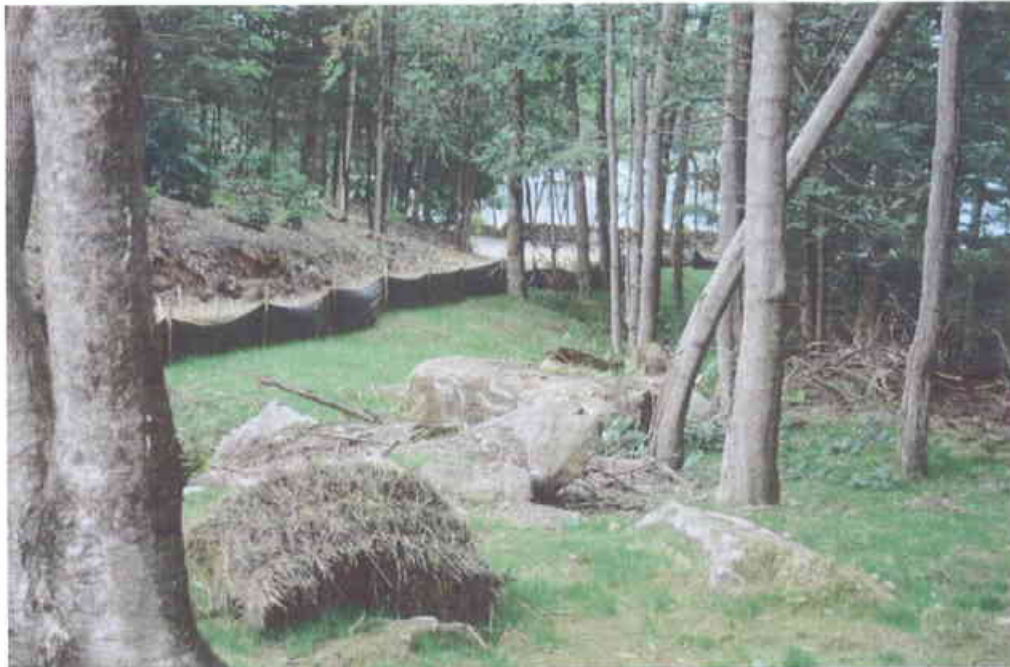
Photo 2C

View of entrance drive from Mashapaug Road.
