# Proposal to get Funding through the Municipal Vulnerability Preparedness Program (“MVP”) to fix the Causeway Problem

## ABSTRACT

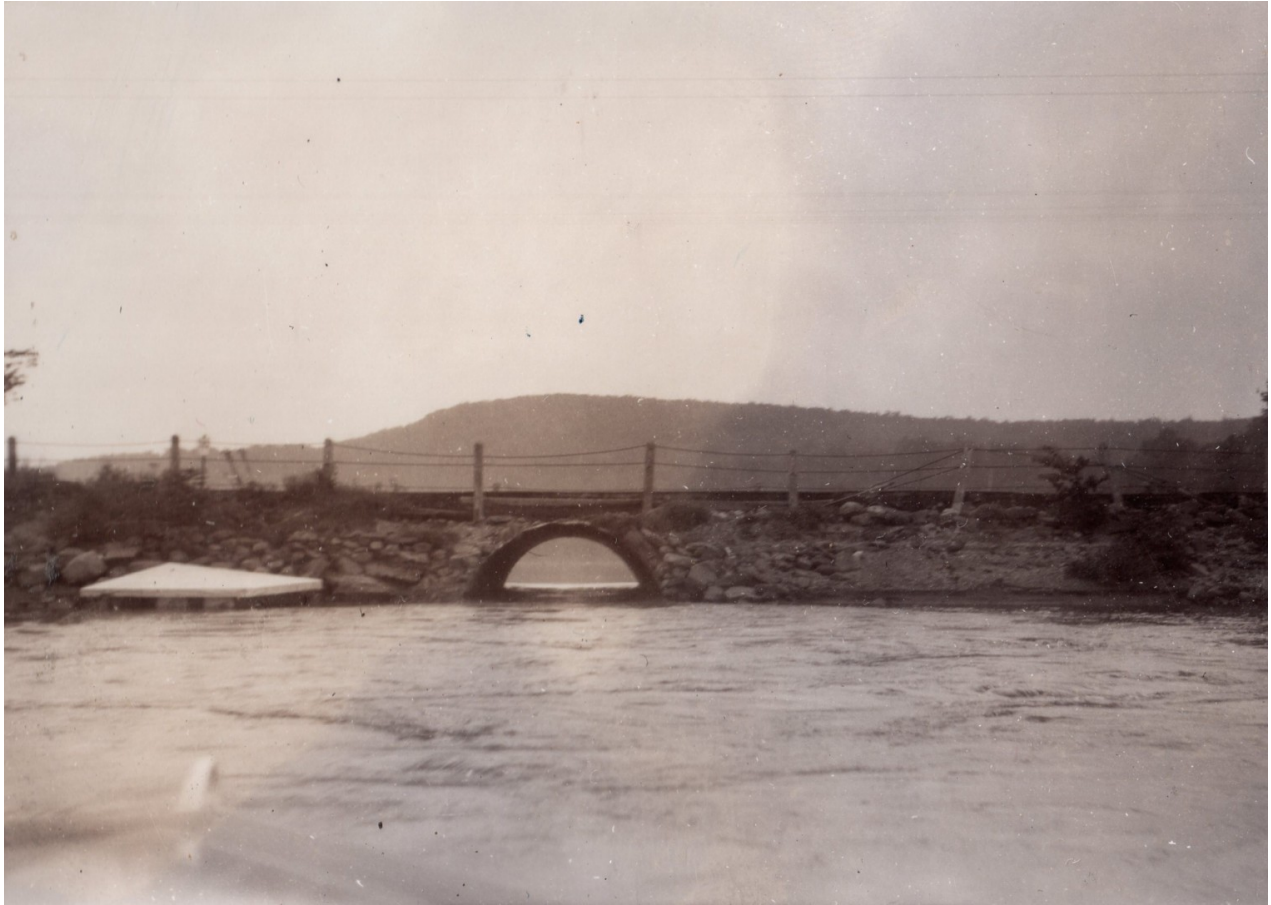
The picture<sup>1</sup>/ below shows the causeway culvert as it existed before the flood of 1955.

This culvert, which was unable to handle the water of the 1955 flood, seems to be larger than the one put in place during reconstruction of the causeway after the flood of 1955.

The motorboat in the picture to the left of the culvert gives an idea about the diameter of the culvert. A motor boat from the 1950's measures about 15 feet; the culvert therefore measured around 10 feet across.

If this culvert would have been able to handle the water in 1955, the causeway would not have been washed away.

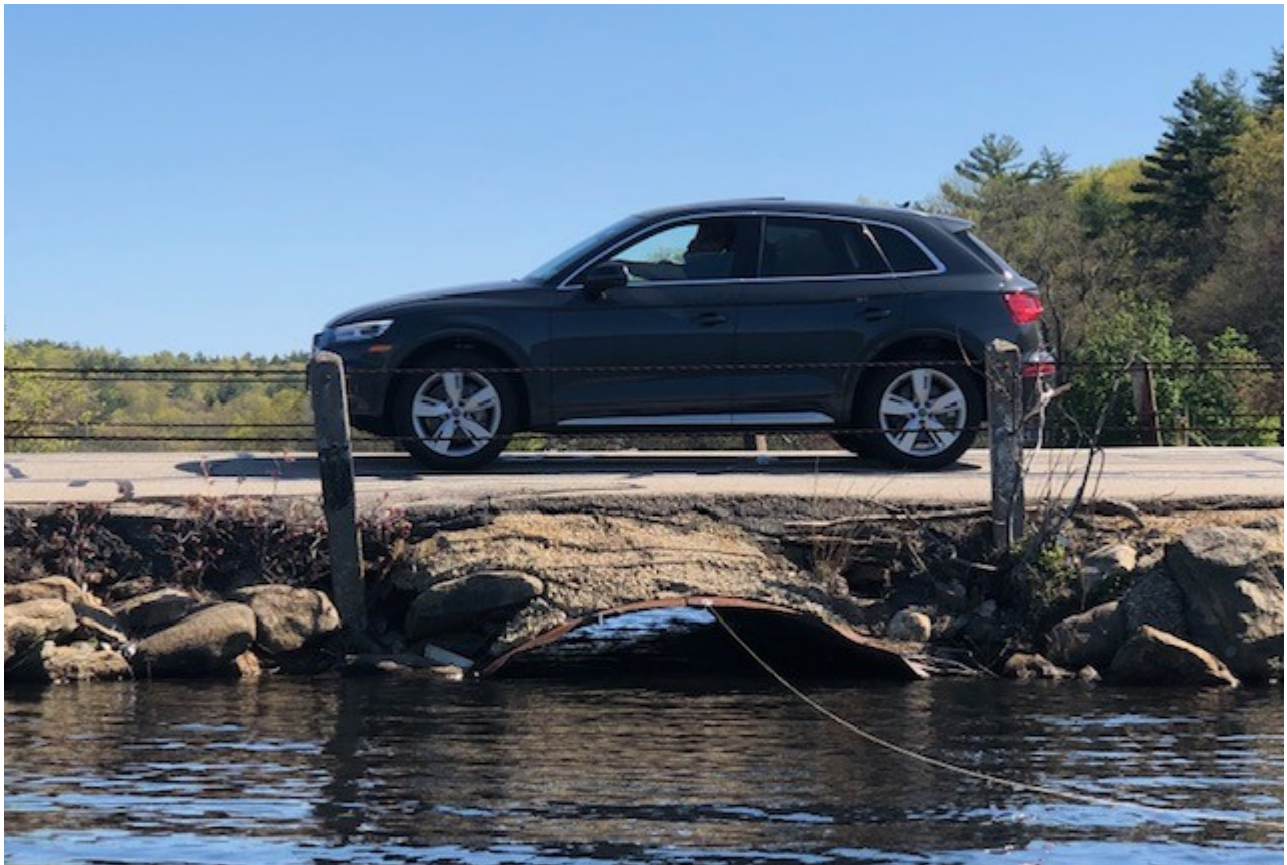
For comparison, the corrugated steel pipe culvert in place at the causeway now is shown in the picture<sup>2</sup>/ below:

PVPC and other involved individuals failed to notice and/or made no effort to look at the culvert; the culvert at the causeway is described as “box-culvert” when it is actually a corrugated steel pipe culvert.

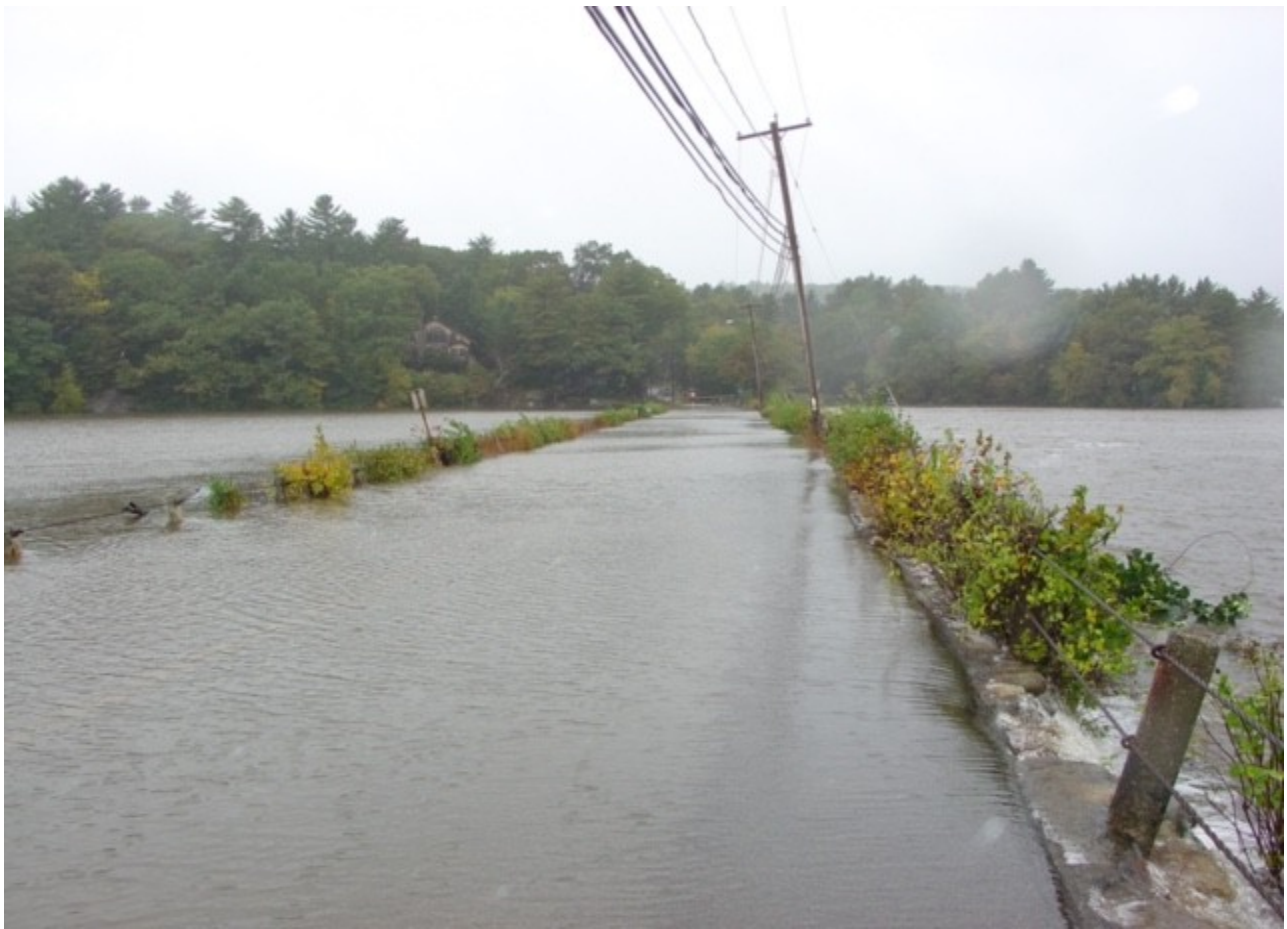
It is noteworthy that the same houses will flood again with lesser precipitation as we saw on October 14/15, as the water-level did not rise any higher after the evening of October 14. For at least another 12 hours, the additional water was not dammed by the causeway any-longer but was washing away part of it as the water reached the top of the causeway and rushed down on the north side, (see picture below).

The image above shows the causeway looking west on the evening of October 14, 2005; in the lower corner on the right you can see the water rushing down the north side of the causeway. By morning of October 15, part of the causeway was washed away.<sup>2</sup> The concrete post in the lower right corner is shown in another picture below from a different angle in a picture taken today, on March 6, 2022.

**The concrete post shown in the picture<sup>3/</sup> on the right above is also shown from a different angle in the picture<sup>3/</sup> above ,showing the flooded causeway looking west. The water level on this side, the north side was no more than 24” above the normal lake-level. The drop of the water level between the south and north basin at least 36 inches on the evening of October 14, 2005.**

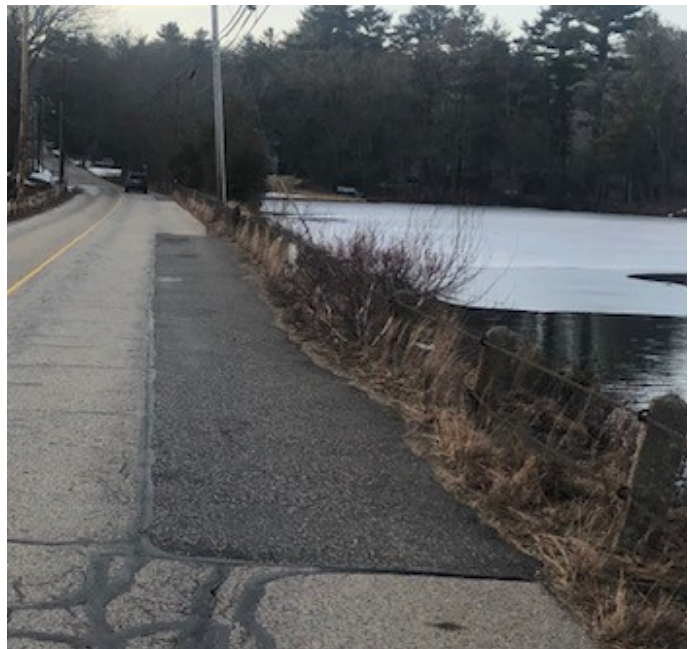
The picture on the right shows one of four repair patches where the water over the causeway washed part of it away. The material which was washed away was filled-

in and the pavement repaired; hence the four patches on the north side to repair the pavement of Mashapaug Road. (This picture was taken today, March 6, 2022.)

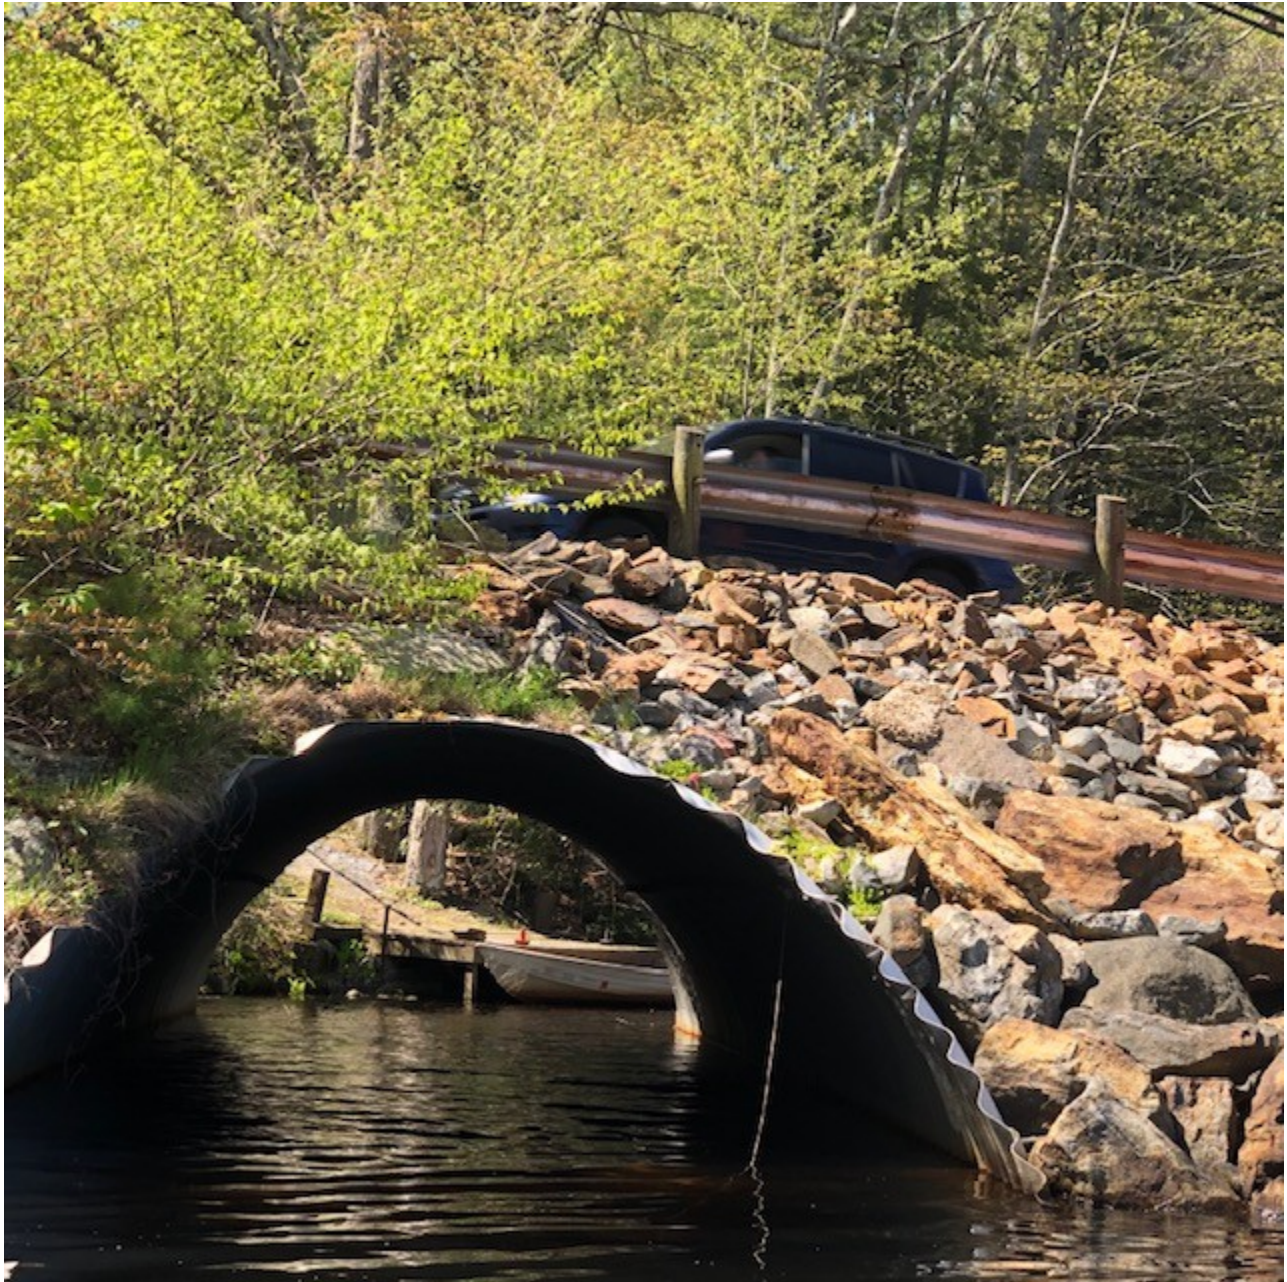
A couple of homes between the west-shore of Hamilton reservoir and May Brook Road south of the intersection of Sandy Beach Road and May Brook Road were also flooded by the Browns Brook. The culvert underneath May Brook Road carrying Browns Brook's water into Hamilton Reservoir is adequately designed (see picture below) and able to handle the water of an event of the magnitude of the flood we experienced in October of 2005.

However, since the causeway dammed the water up to five foot and six inches above normal water-level, the culvert was submerged and was unable to carry the water of Browns Brook, the water found

its way of least resistance which was through the homes to the north of the culvert. The picture<sup>3/</sup> of the culvert mentioned above located under May Brook Road, south of the intersection of Sandy Beach Road and May Brook Road, is taken with the same lens with the same distance to the culvert as the picture above taken of the culvert of the Mashapaug Road causeway. The culvert underneath May Brook Road is clearly larger than the causeway culvert and able to handle the water stemming from Browns Brook (Brown's Brook is wrongly identified as May Brook throughout the [LHMP2016](#) report. While the [LHMP2016](#) report fails to recognize the fact that the causeway culvert is undersized, the report fails to recognize that the May Brook culvert is adequate and suggests to enlarge the May Brook Road culvert. See page 32 of the [LHMP2016](#) report.

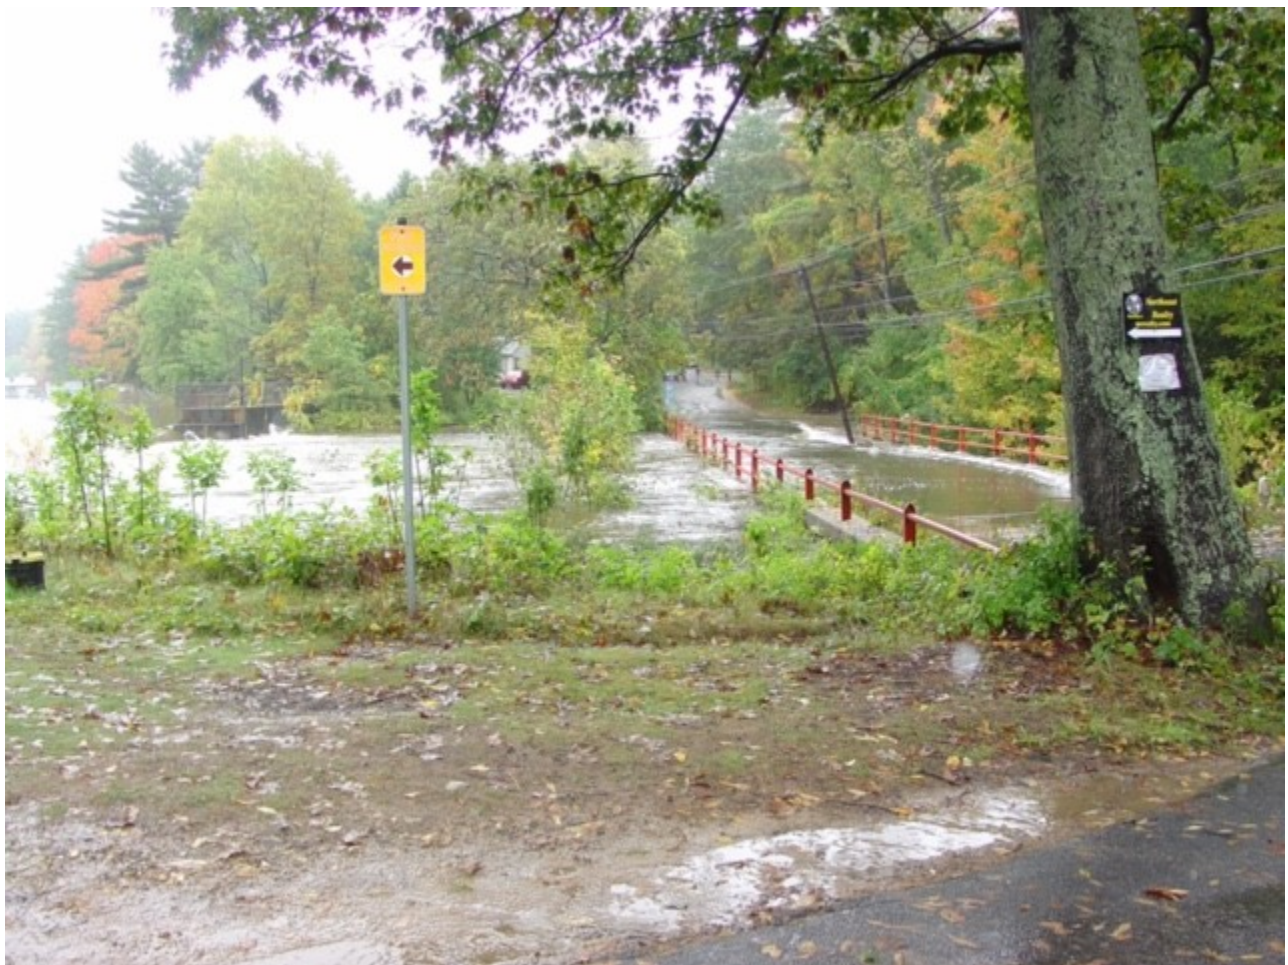
The picture<sup>2/</sup> below was taken in the morning of October 15, 2005, showing the water flooding the Sturbridge Road bridge at the dam. The bridge also functioned as a dam. The water is at its highest level at the time this picture was taken.

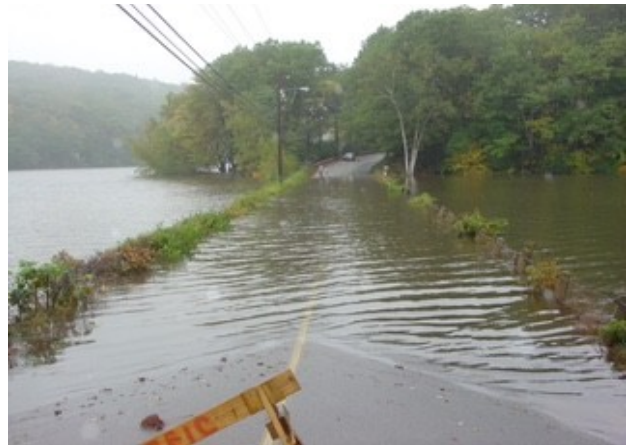
Lets assume that the [LHMP2016](#) intended to keep the causeway passable as an escape route and for that reason proposed raising the causeway; what about the little causeway?

Eliminating the causeway problem of the large causeway would also eliminate the problem of the little causeway.
